BBACA ENGINEERING, LLC

PROPERTY CONDITION ASSESSMENT

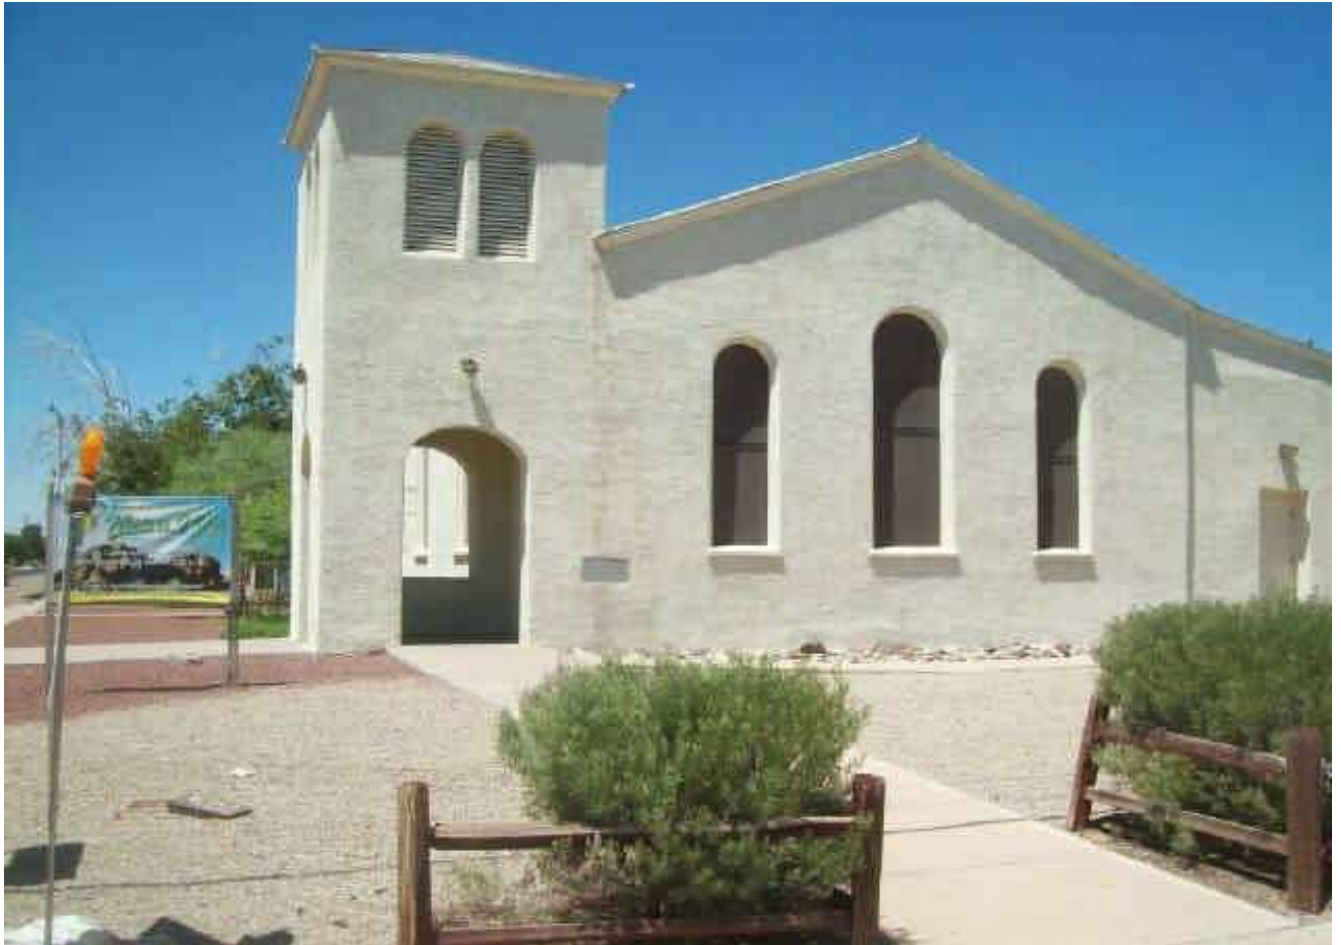
**CHURCH
1234 E. SOME PLACE
ANYWHERE, AZ**

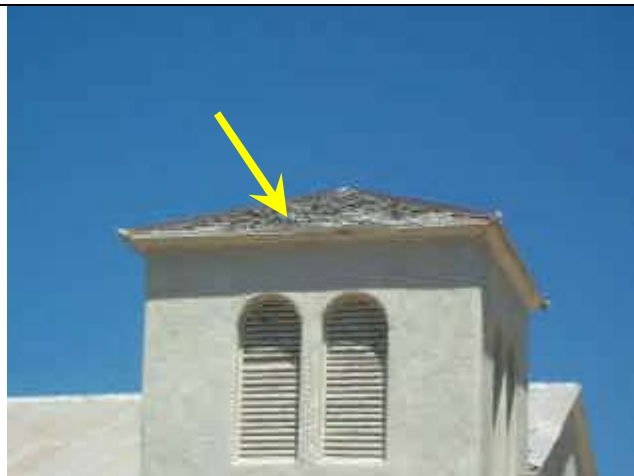
Photo 2: Composition shingle surface worn and deteriorated over chapel bell tower.

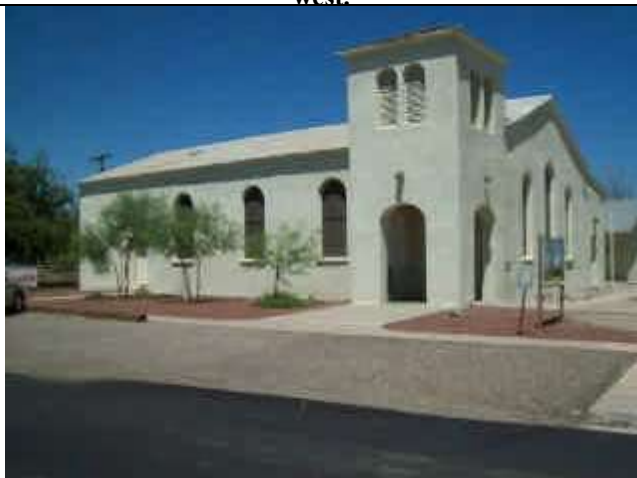
Photo 3: South exterior view of chapel.

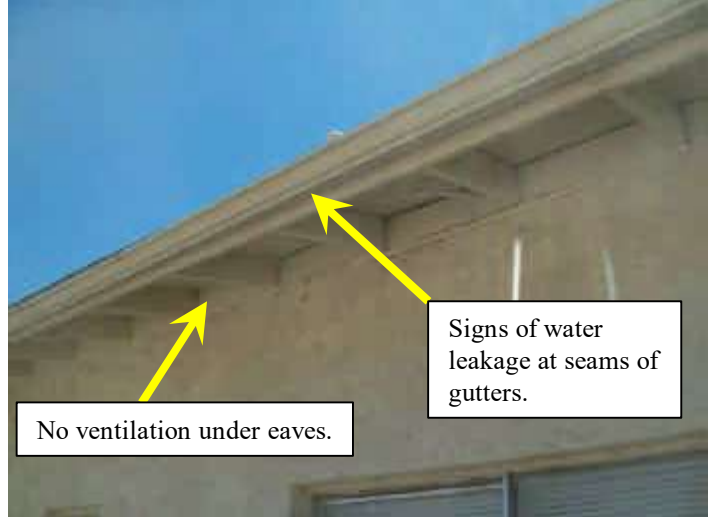
Photo 10: Signs of leaks at gutter seams and no ventilation noted under eaves.

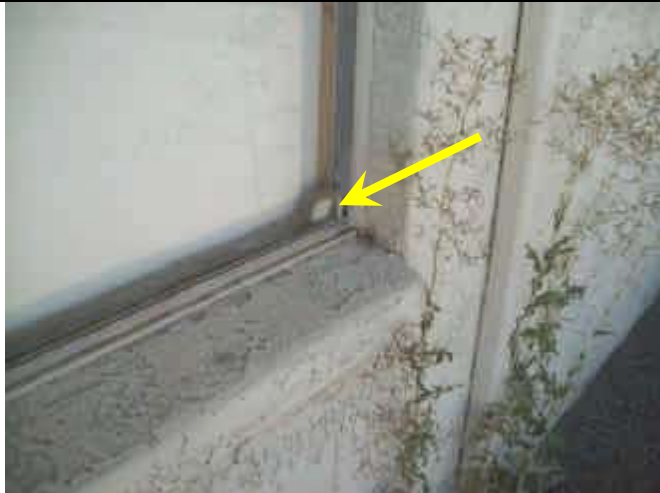
Photo 11: Exterior plastic molding worn and deteriorated around single pane windows of classroom building.

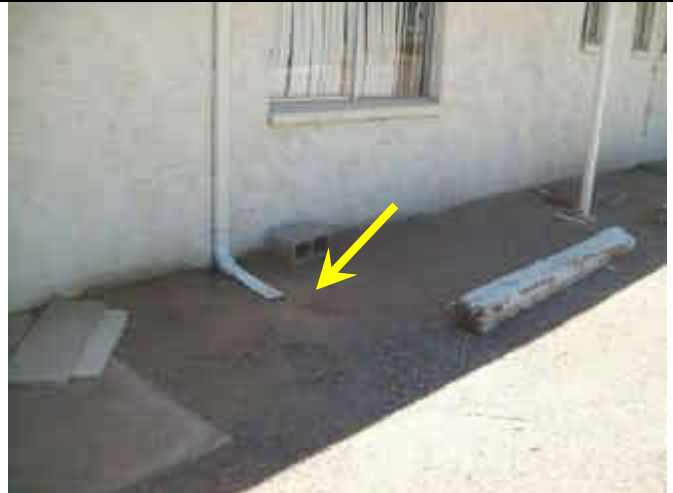
Photo 12: Downspout flattened along north edge of classroom building.

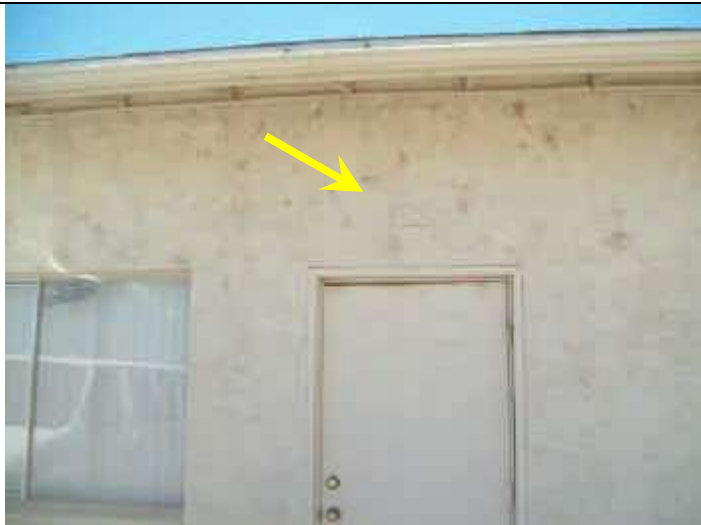
Photo 13: Distress cracks in masonry joints on north exterior wall over door.

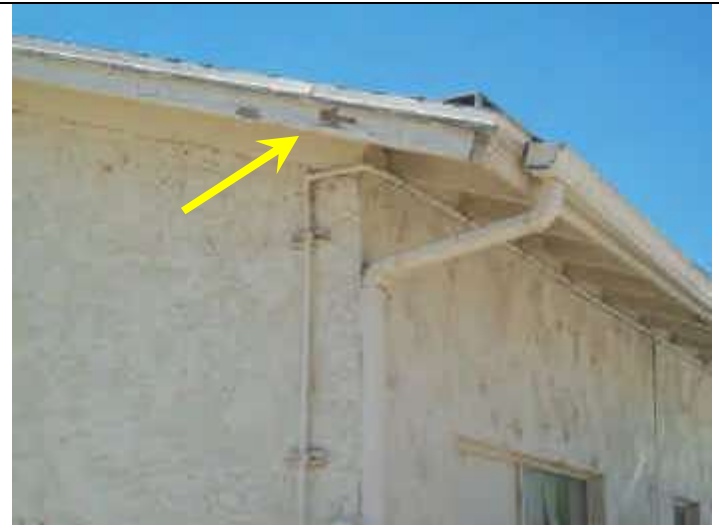
Photo 14: Paint surface worn and deteriorated on wood fascia, trim and eaves of classroom building.

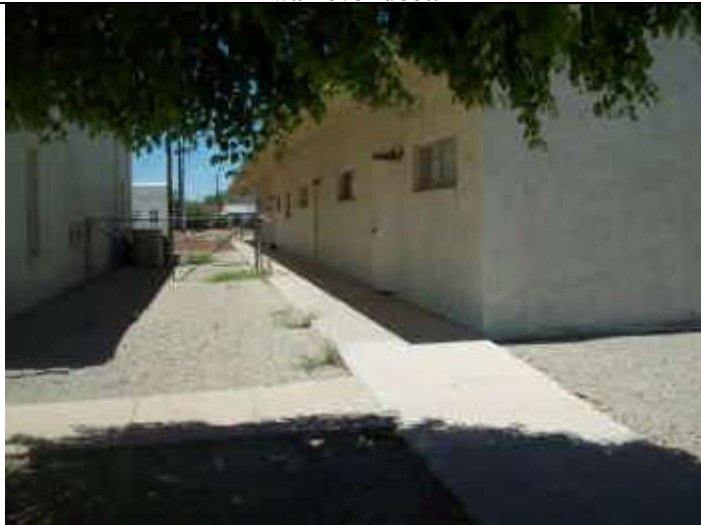
Photo 15: View between buildings looking west showing walkway area(s).

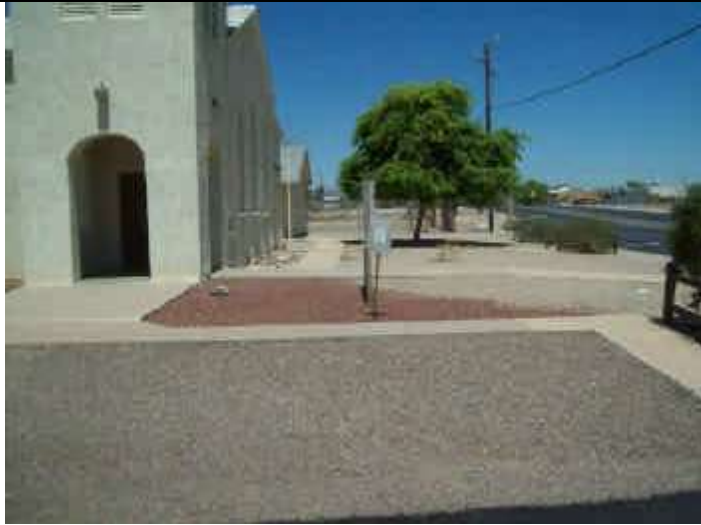
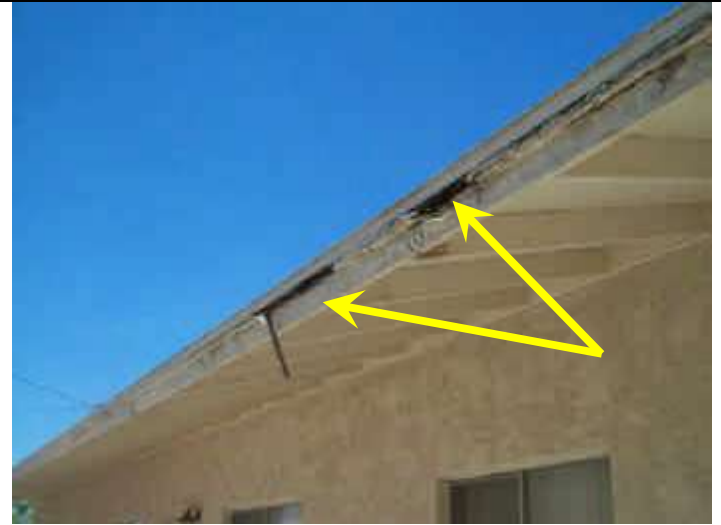
Photo 19: Handicap parking space & signage at east end of south parking lot.

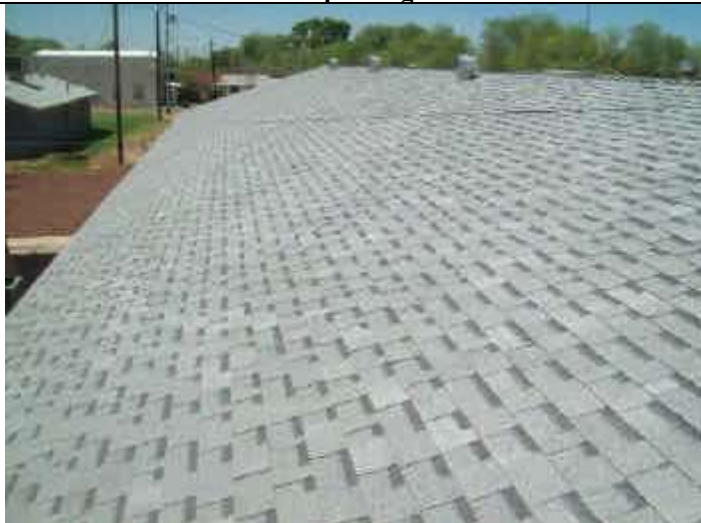
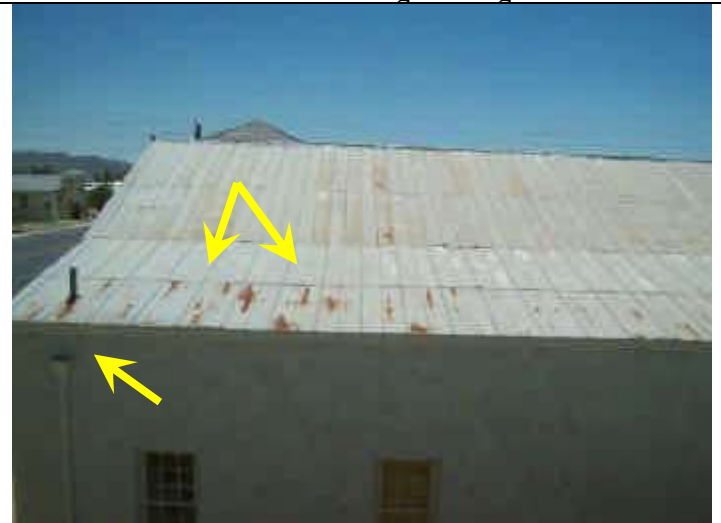
Photo 21: Composition shingle roof surface view south slope of classroom building and typical.

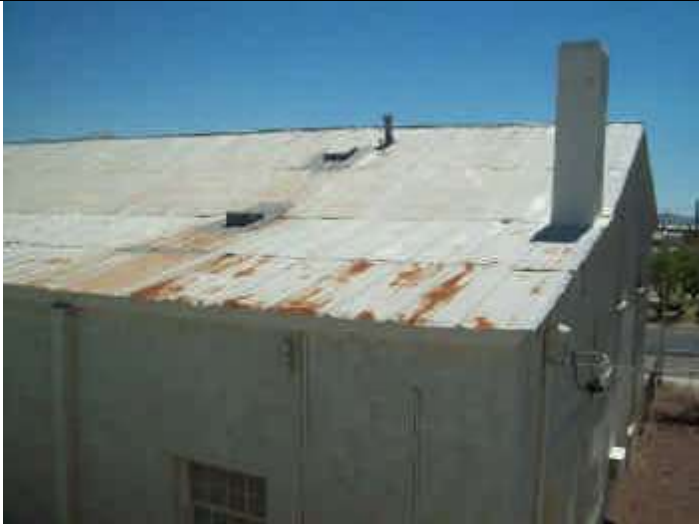
Photo 23: Standing seam metal roof surface view north slope west end of chapel. Rusting noted at bottom edges.

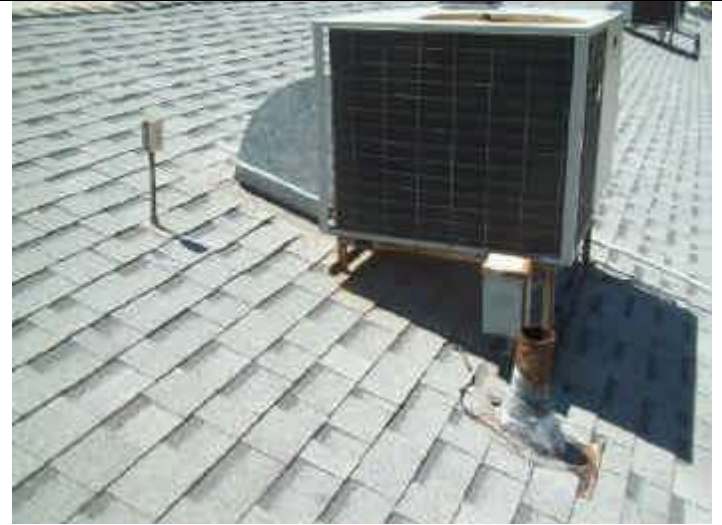
Photo 24: Roof mounted packaged heat pump view on north slope of classroom building roof.

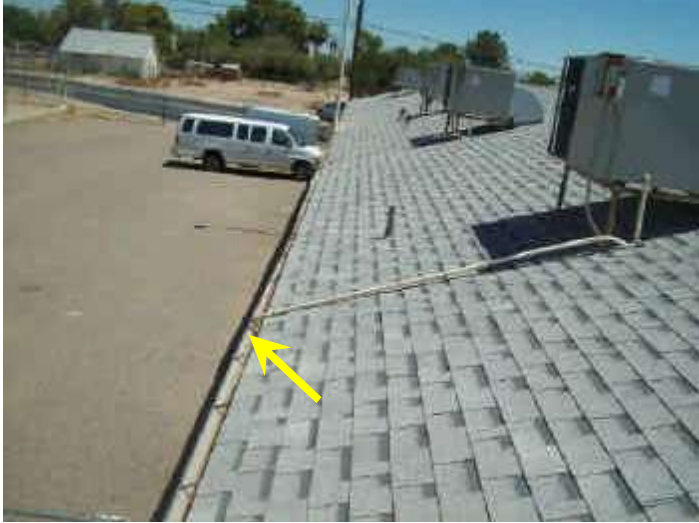
Photo 28: No metal flashing noted around electrical mast head at west end of classroom building roof.

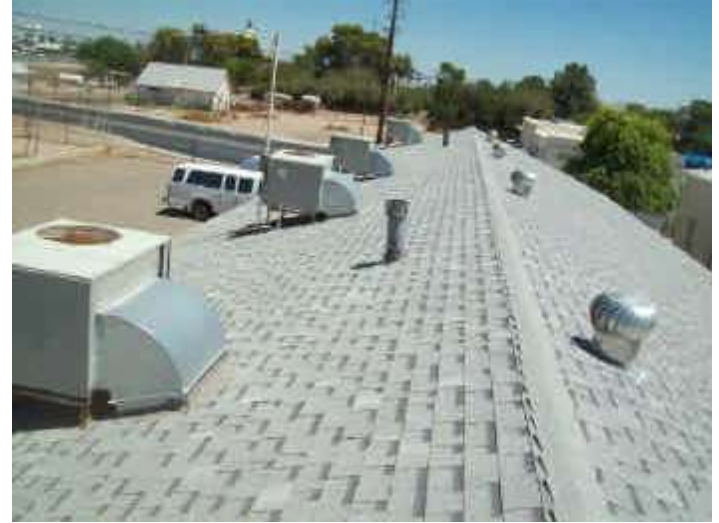
Photo 29: Excessive debris in gutters and gutters bent outward along bottom north edge of classroom building roof.

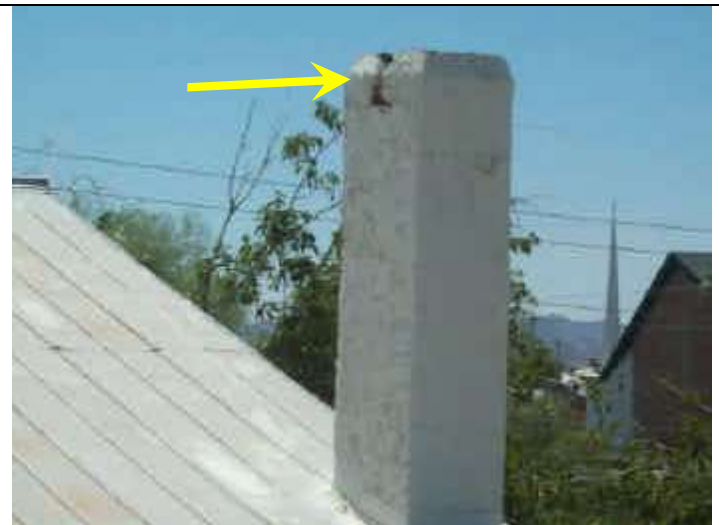
Photo 32: Damage along top edge of chimney stack at west end of chapel building roof.

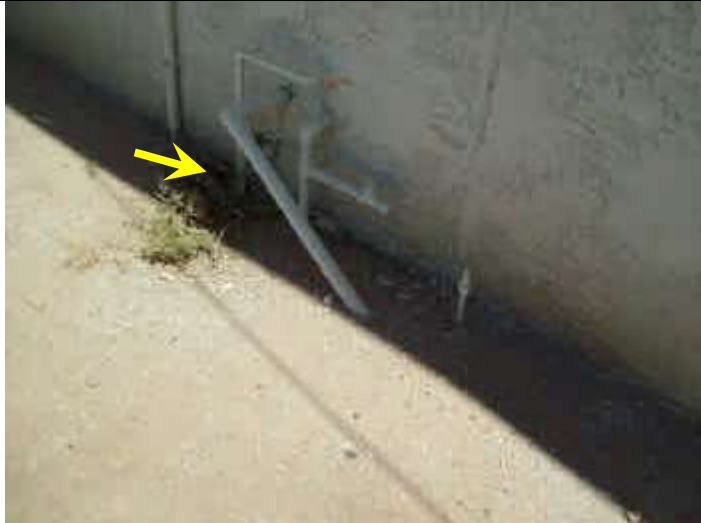
Photo 33: Sewer line comes off north exterior wall of chapel into ground.

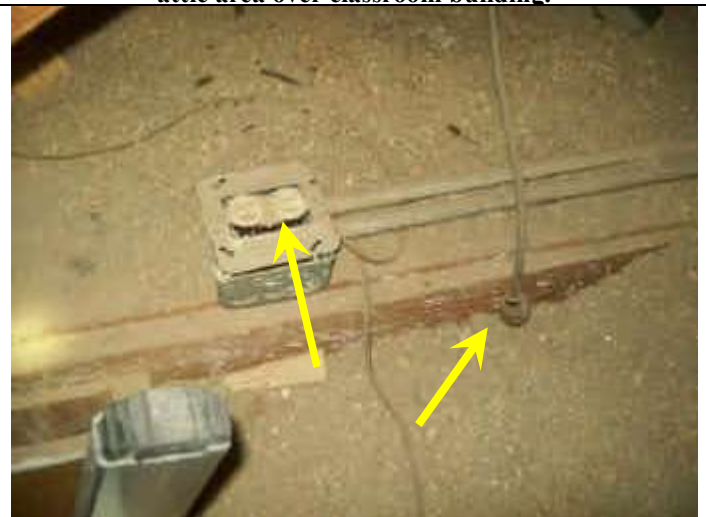
Photo 42: Extension cord wiring & two-prong outlet noted in attic area over classroom building area at scuttle.

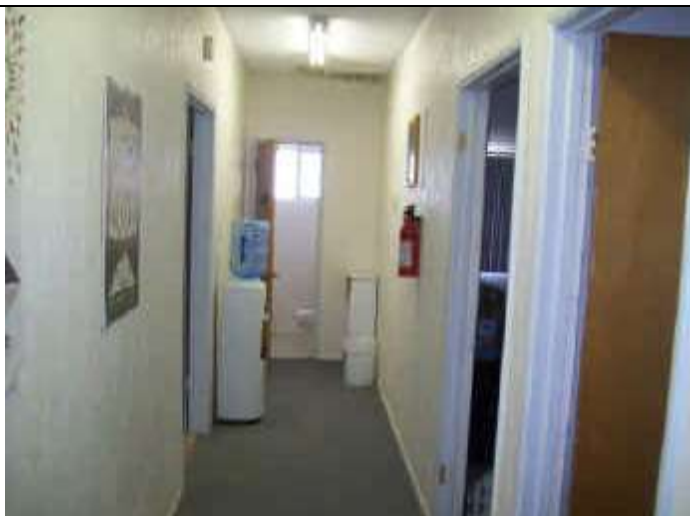
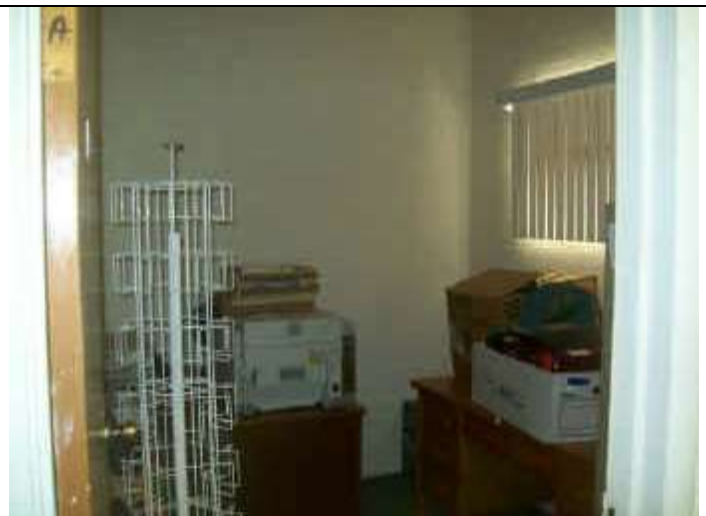
Home & Building Inspection Specialists

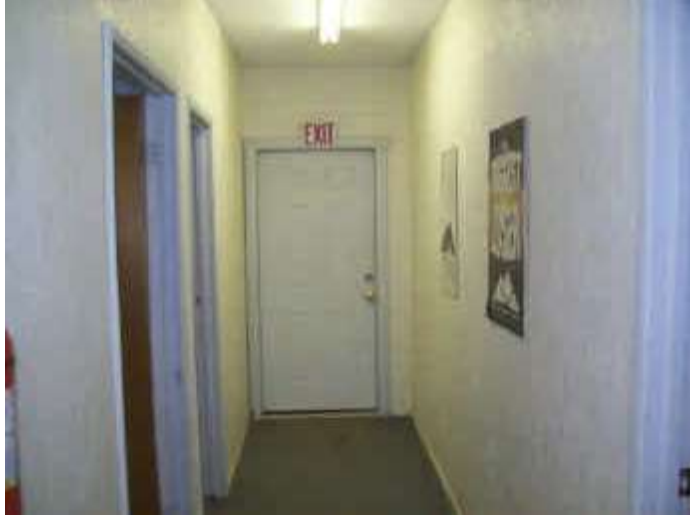
Photo 45: Hallway view looking south at east end of classroom building where office areas noted.

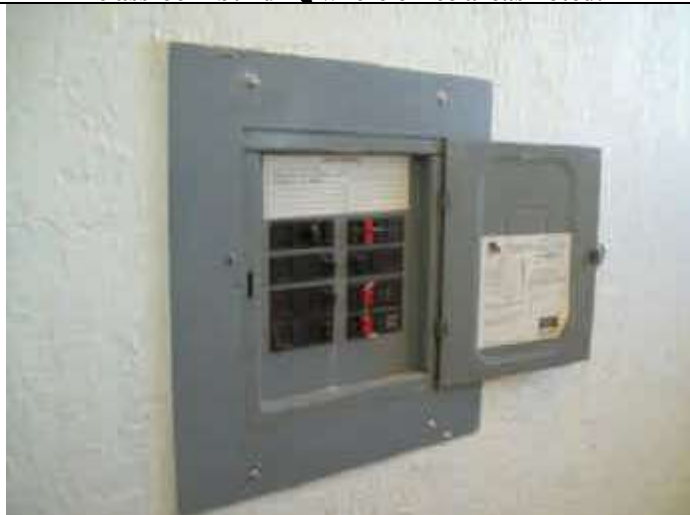
Photo 47: Electrical sub-panel, in east hallway bathroom of classroom building.

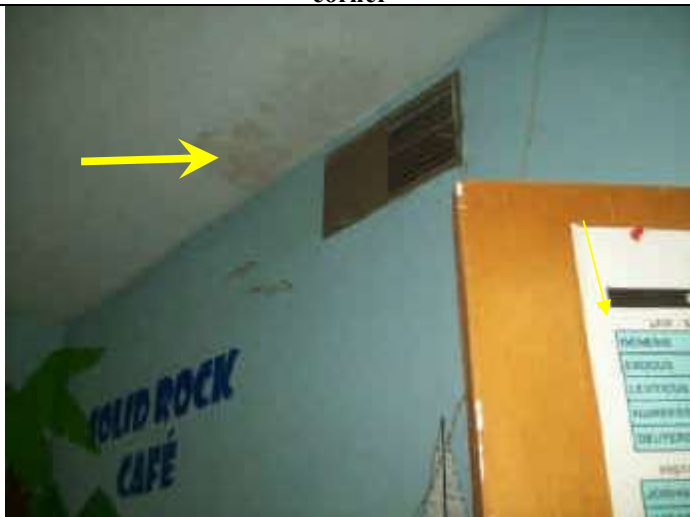
Photo 51: Water stains on ceiling acoustic panels along west edge of child care area.

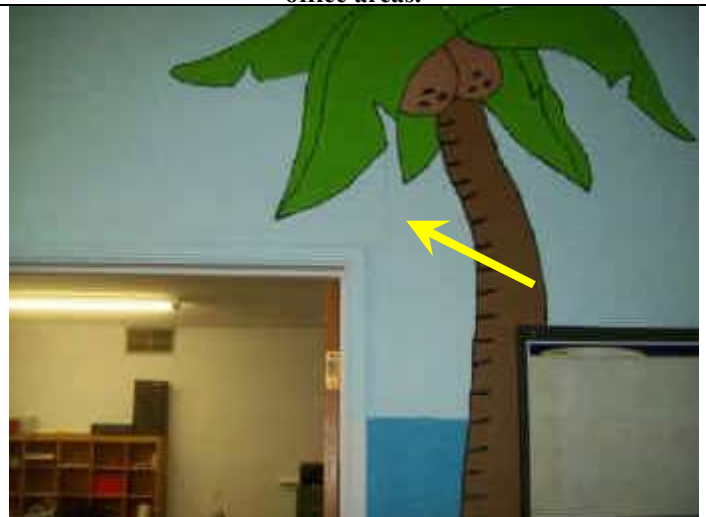
Photo 52: Distress crack on west wall of child care area of classroom building over entry door.

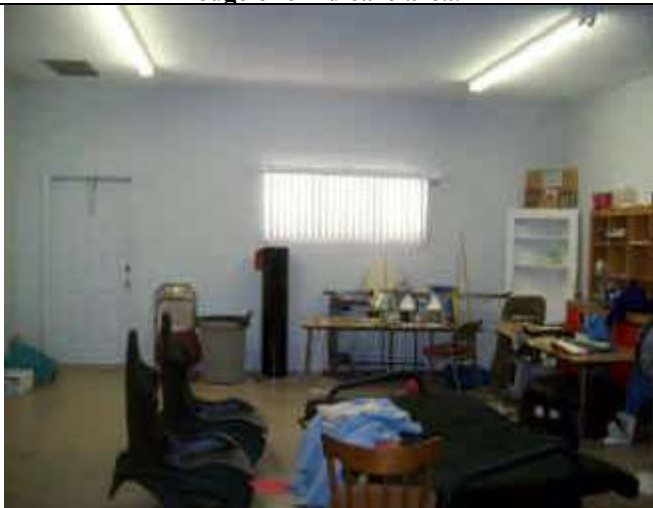
Photo 53: Secondary child care area just east of kitchen and social hall.

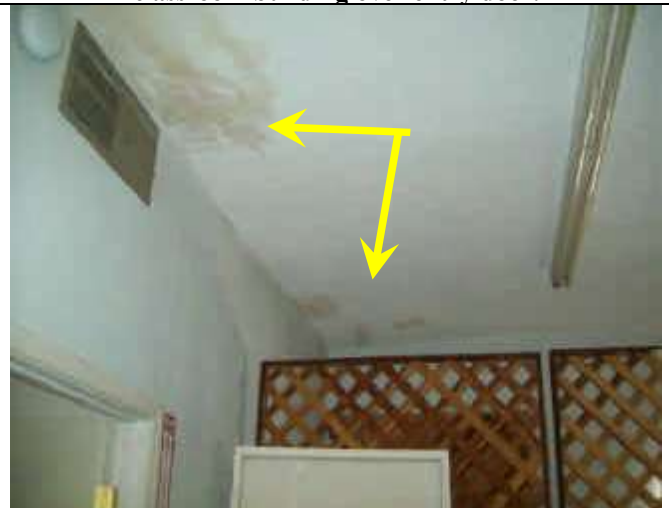
Photo 54: Water stains on ceiling acoustic panels in secondary child care area just east of kitchen area. .

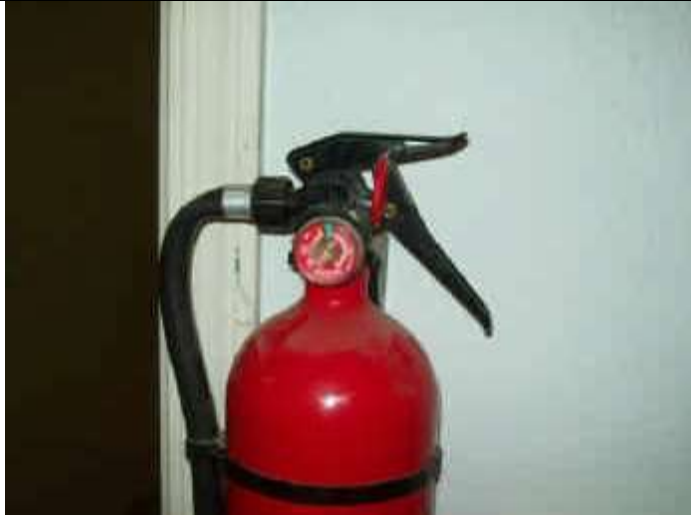
Photo 55: No certification tags on fire hydrants in classroom building areas.

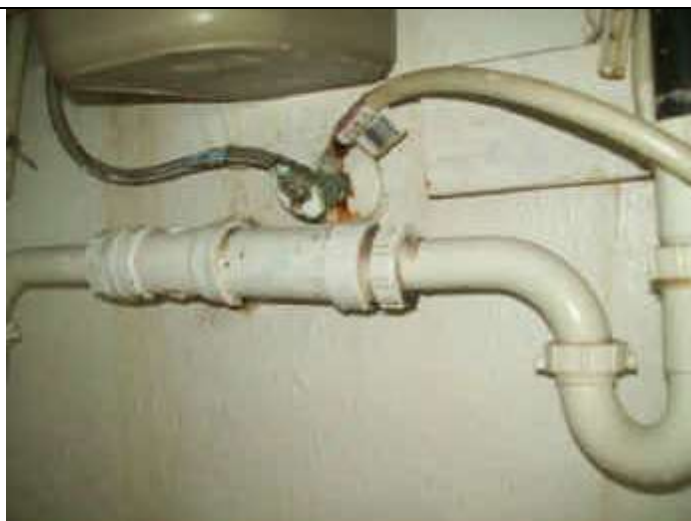
Photo 59: Signs of rusting and previous water leaks under sinks in kitchen hallway area.

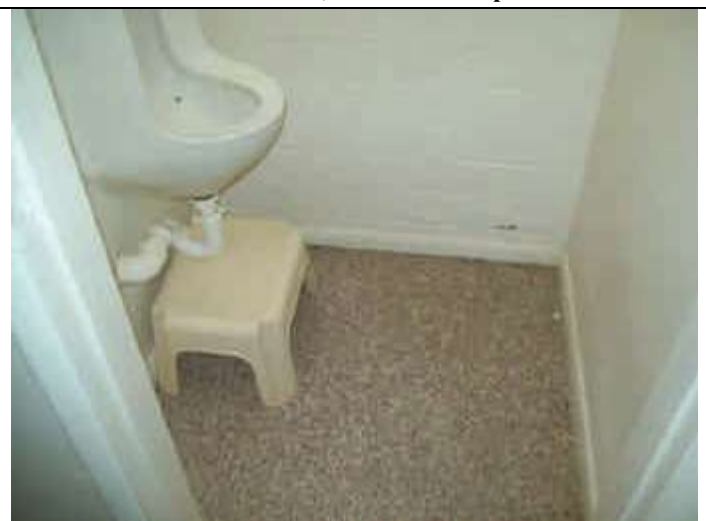
Photo 60: Urinal view in men's restroom in kitchen area.

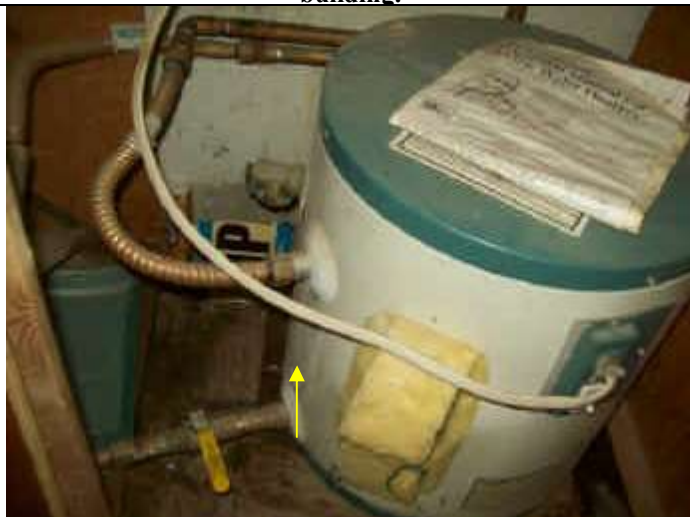
Photo 63: Electric water heater installation in kitchen under cabinets. Water leakage noted at TPR valve. .

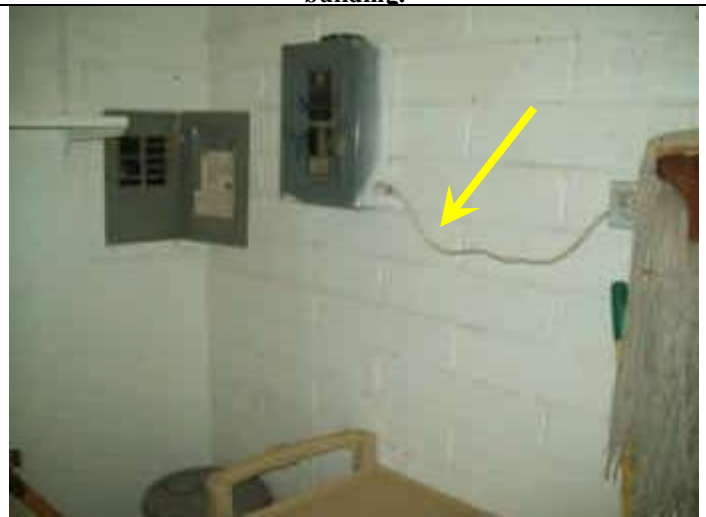
Photo 64: Exposed Romex wiring in storage area by kitchen in classroom building. .

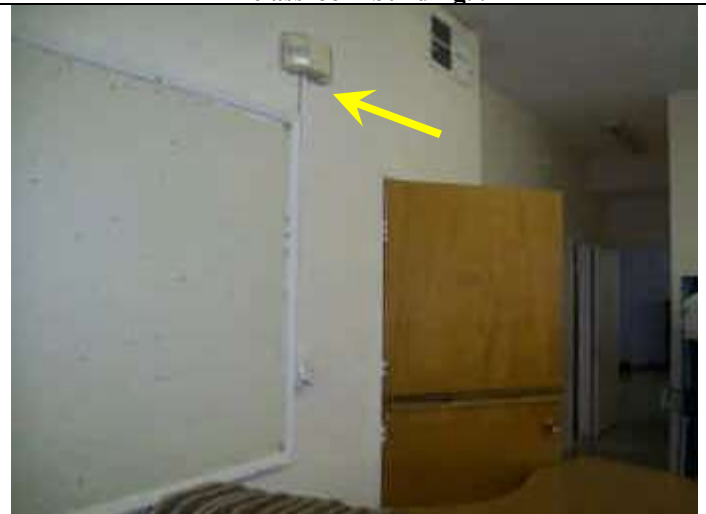
Photo 66: Emergency lighting noted in social hall along north interior wall.

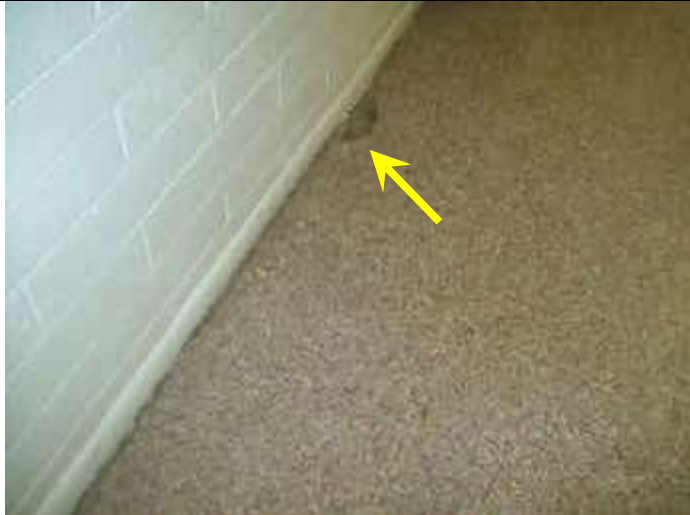
Photo 67: Gaps and tile flooring damaged along south edge of social hall in classroom building.

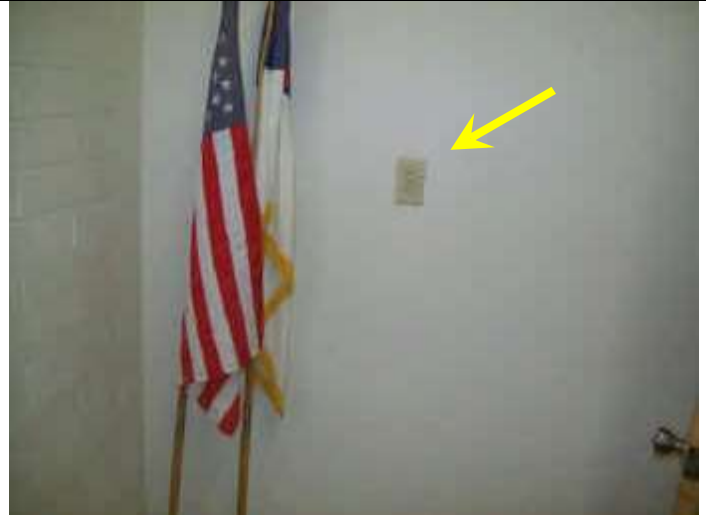
Photo 68: Two-prong outlets noted in storage room of kitchen hall area.

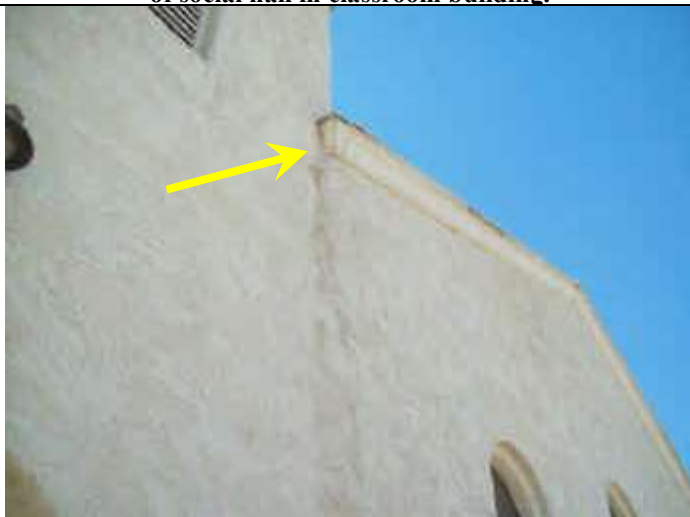
Photo 69: Water drains onto stucco surface along east wall of chapel area. .

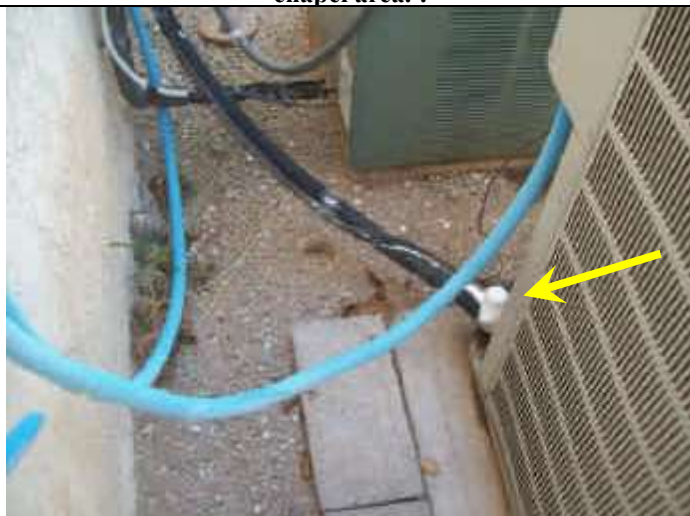
Photo 71: Icing of exterior refrigerant line noted for chapel HVAC compressor/ condenser unit.

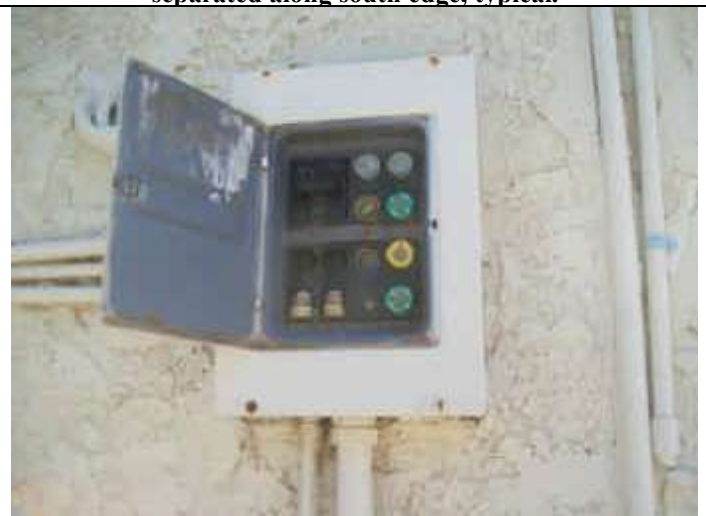
Photo 72: Wiring over-fused in electrical panel on north exterior wall of chapel.

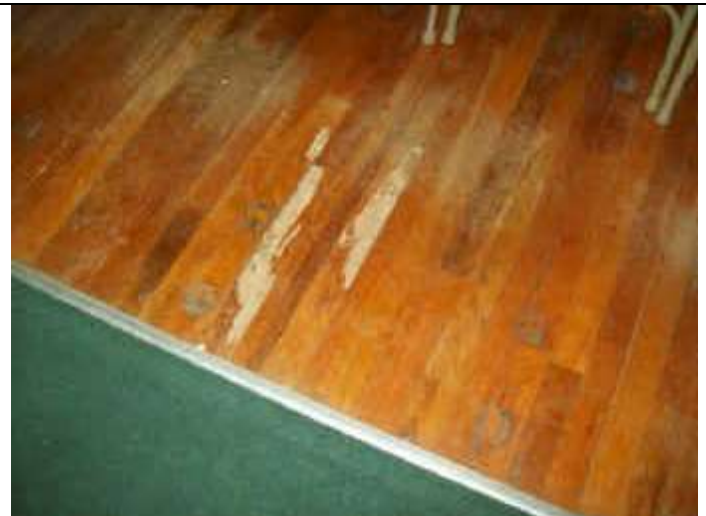
Photo 78: Wood flooring damaged by wood destroying insect activity along east edge.

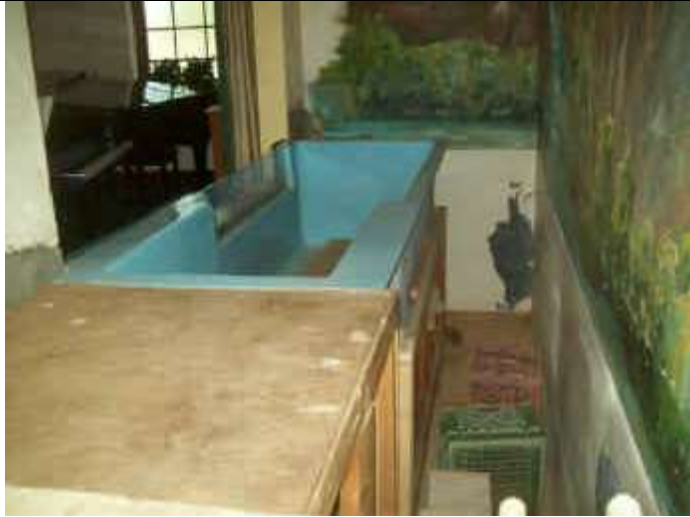
Photo 79: Baptismal bath tub view in chapel by alter area.

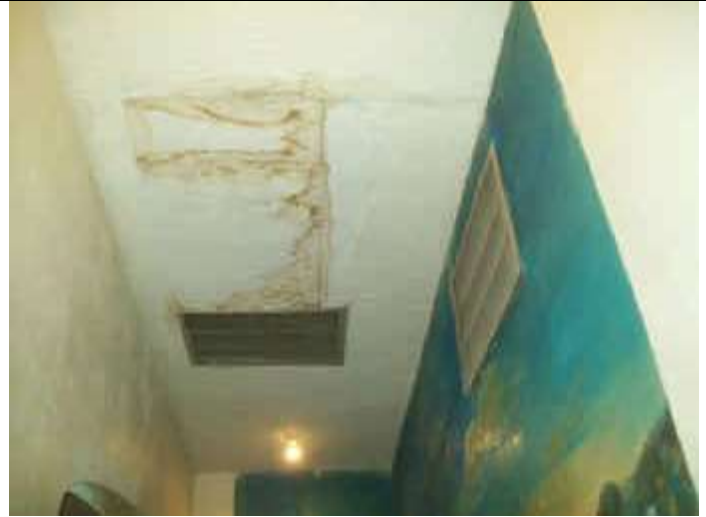
Photo 80: Excessive water staining on ceiling above baptismal tub in chapel area at alter end.

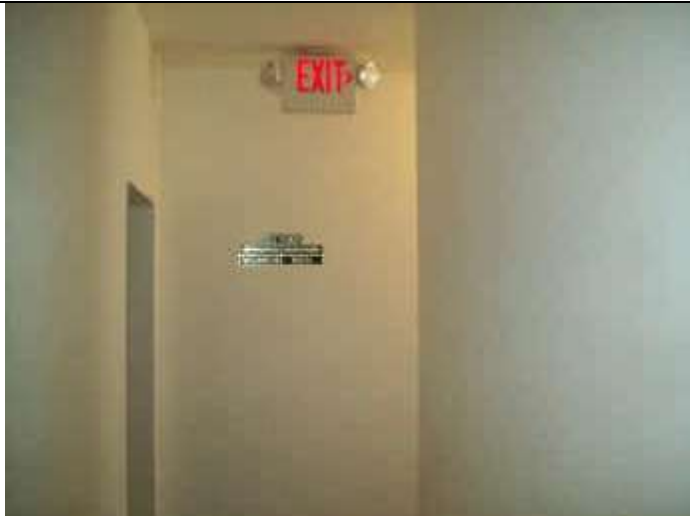
Photo 81: EXIT signage lit and emergency lighting in chapel hallway areas.

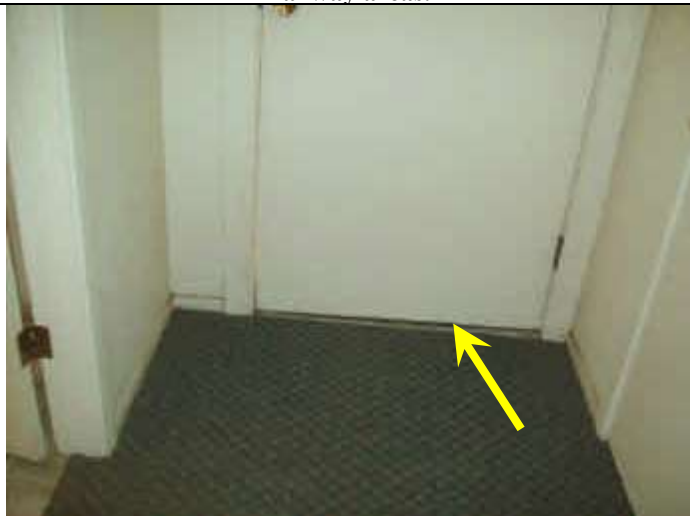
Photo 83: Weather stripping worn around exterior doors of chapel building.

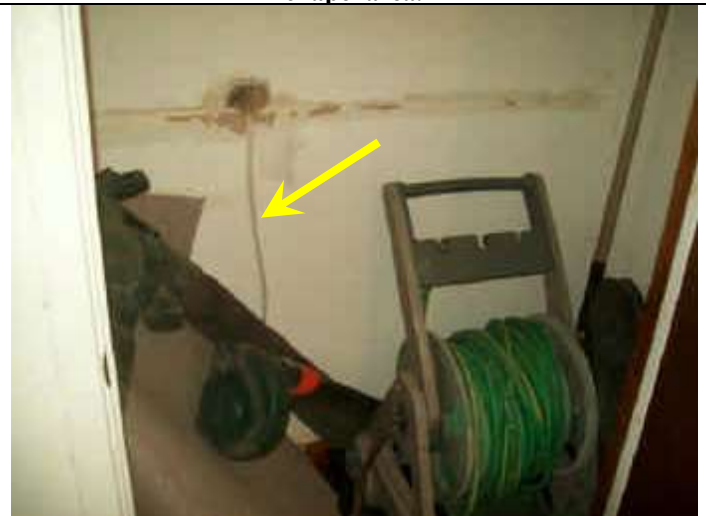
Photo 84: Exposed Romex wiring in storage room at rear or west end of chapel area.

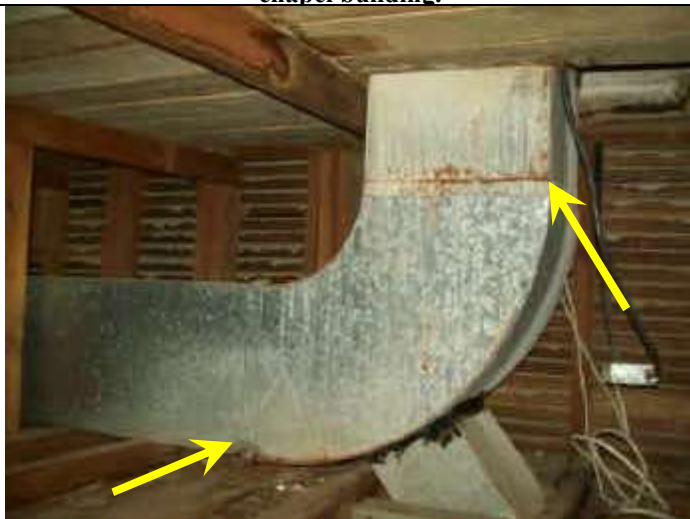
Photo 87: Rusting and signs of water leakage in AC ducting for chapel in NW attic area.

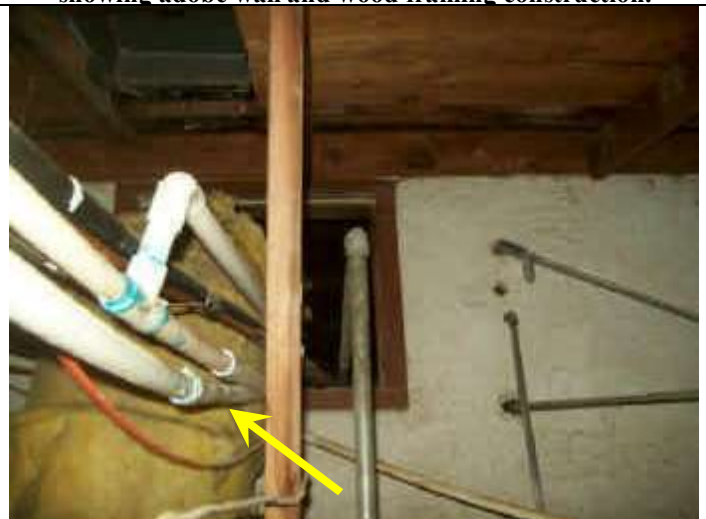
Photo 88: HVAC water condensation line droops in attic area above chapel in NW attic area.

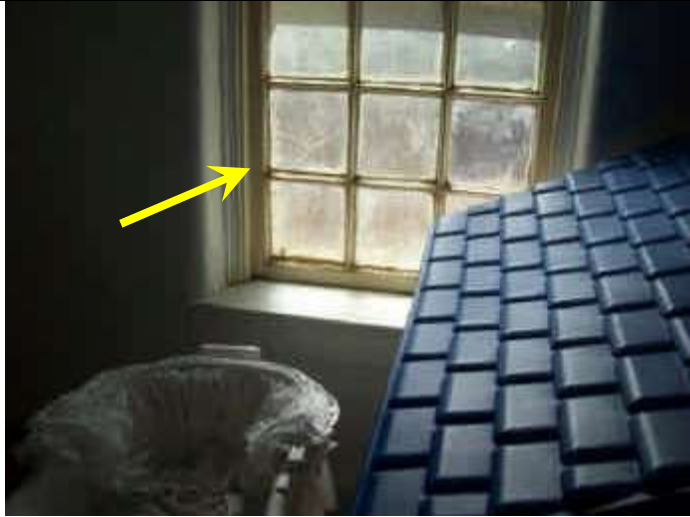
Photo 91: Broken glass panes on rear exterior wood windows.

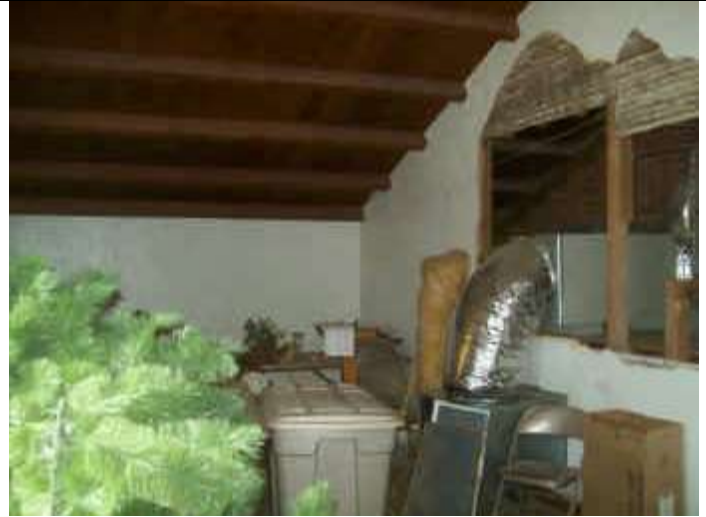
Photo 92: Rear interior storage area of chapel and access to HVAC air handler installations.

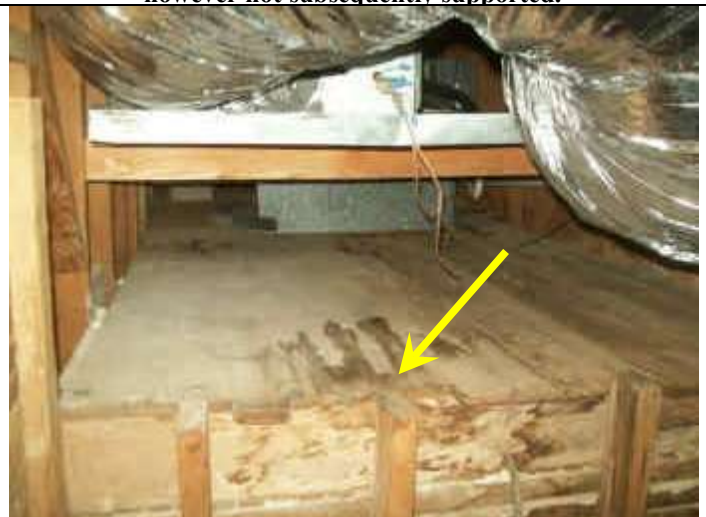
Photo 100: Water stains below HVAC condensation pan at rear of chapel building.

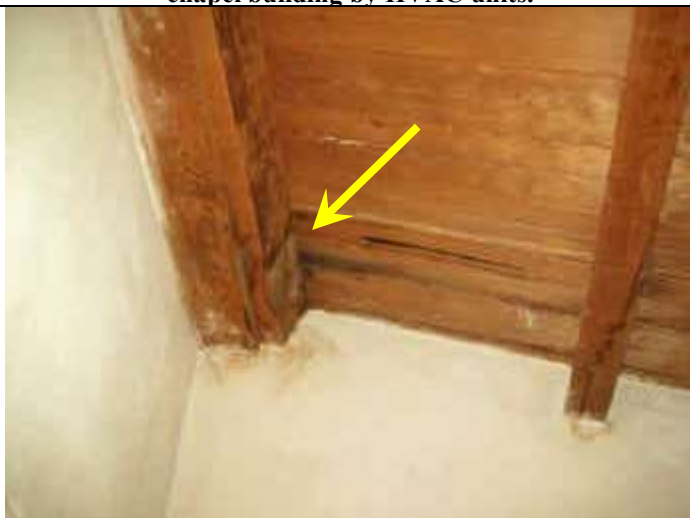
Photo 101: Water stains on wood ceiling area at rear of chapel building south of HVAC installations.

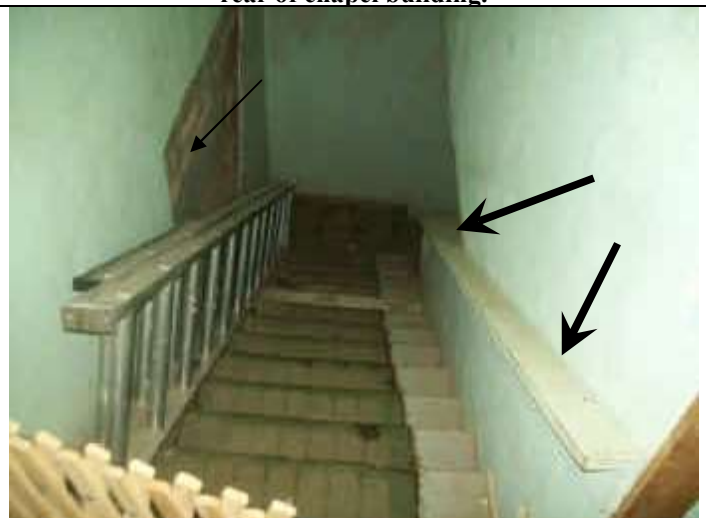
Photo 102: No 'graspable' rail for stairway to basement area in chapel building.

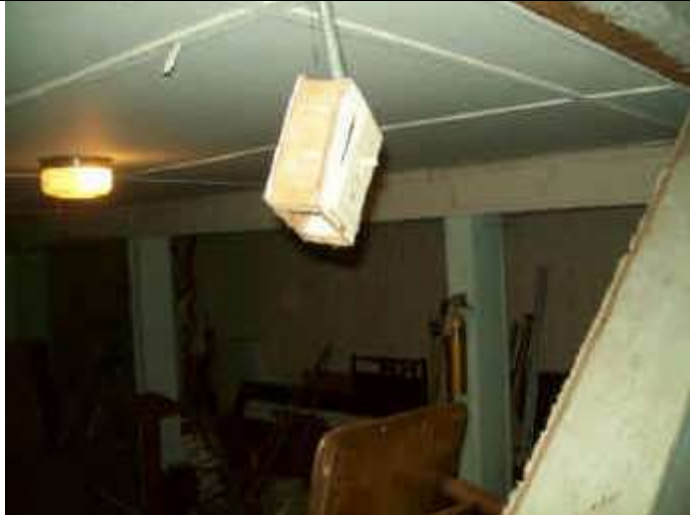
Photo 103: Loose switch outlet at entrance to basement area.

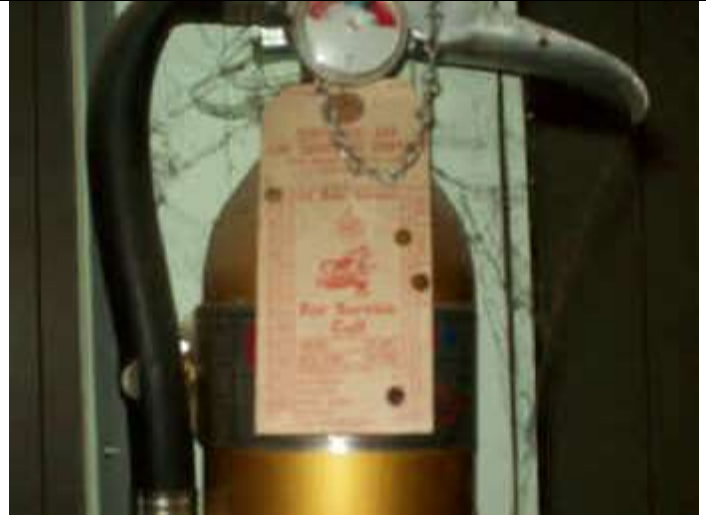
Photo 104: Old fire extinguisher whose certification is over due.

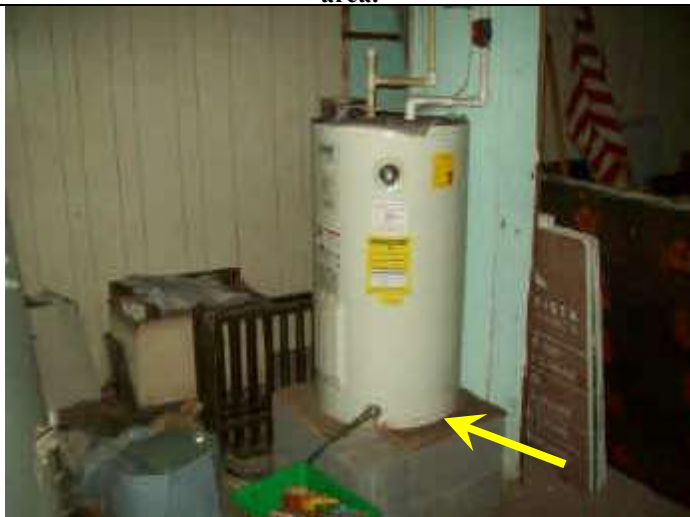
Photo 111: Electric water heater installation in basement of chapel, old unit. With signs of rusting.

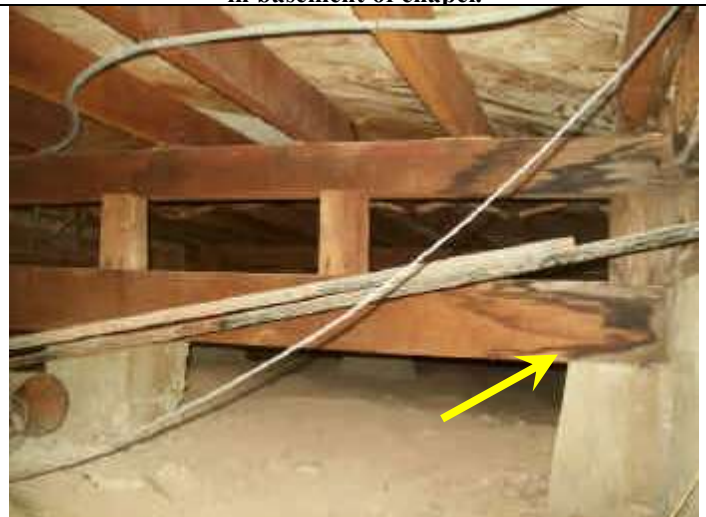
Photo 112: Crawl space view under main chapel area. Water stains noted on header supports west end.

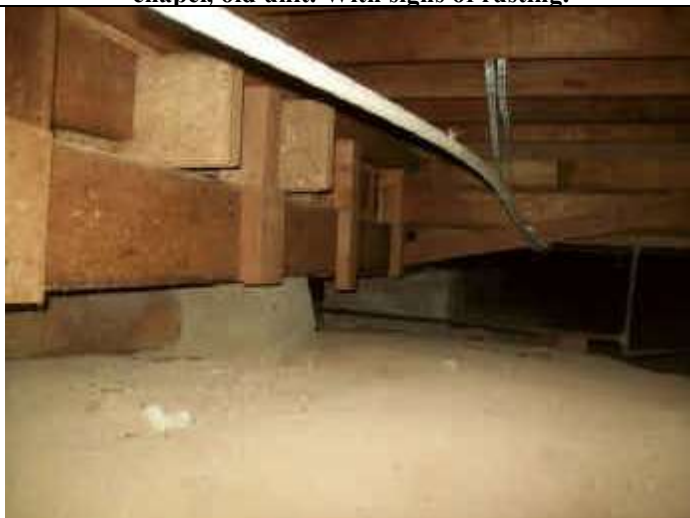
Photo 113: Crawl space view under main chapel area showing wood pier, post and beam supports.

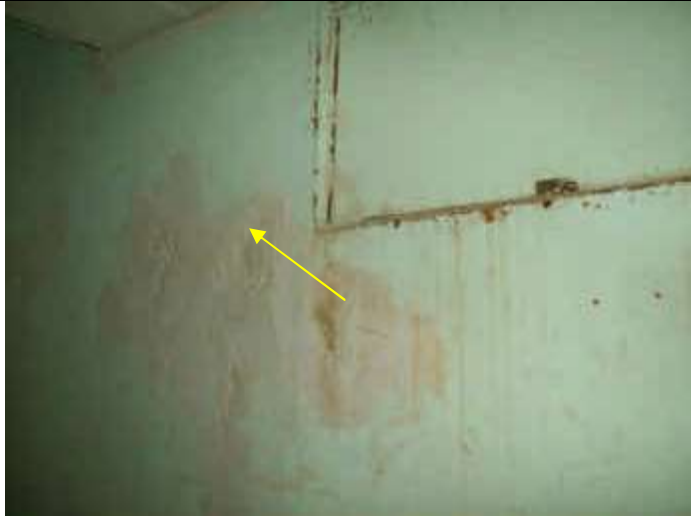
Photo 115: Water stains on interior walls of basement area.
