BBACA ENGINEERING, LLC

PROPERTY CONDITION ASSESSMENT

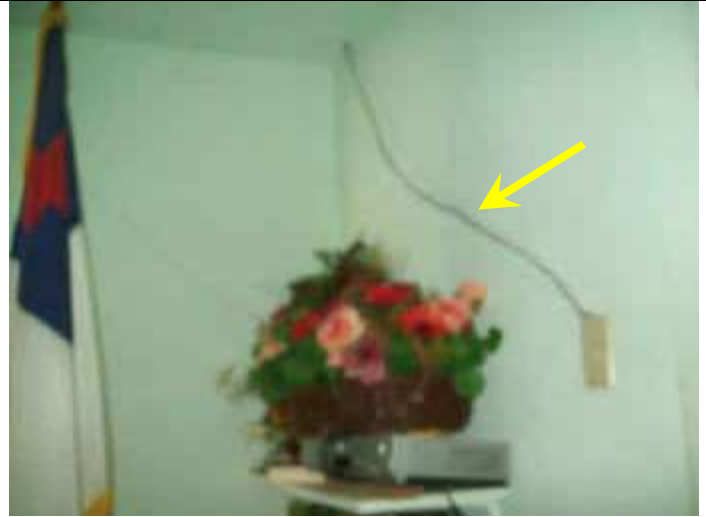
Photo 116: Exposed Romex wiring on interior wall of basement area.
