Property Inspection Report

Client: John Doe
Property Location: 1234 S. Anywhere Place
USA

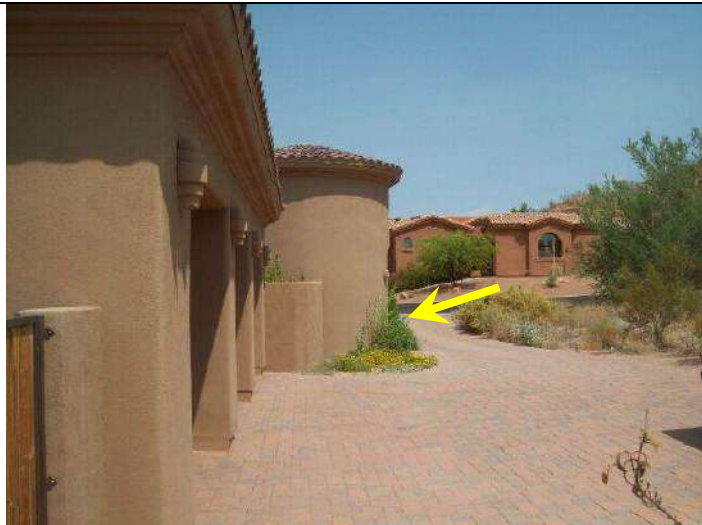
1. There was a negative grade and low spot along the front exterior at its east end (see photos 3 & 4). This can allow water to drain/ or accumulate near the main home foundation. Provisions should be made such as improved grading, or the installation of gutters & downspouts, French drains, etc. to insure that water drains away from the foundation. Also, the watering of plants in this area should be monitored so that an excessive amount of moisture does not accumulate as a result. This will maintain a more stable soil content there and help in preventing any more than normal settlement from occurring. We mention this because water accumulation near the foundation and foundation supports is a frequent source or contributor to its movement/ or settlement and can also be a source of attraction for termites.

2. There was no access for water to drain from flower bed areas along the east exterior (see photo 3). This can allow water to drain/ or accumulate near the main home foundation. Provisions should be made such as improved grading, or the installation of gutters & downspouts, French drains, etc. to insure that water drains away from the foundation. Also, the watering of plants in this area should be monitored so that an excessive amount of moisture does not accumulate as a result. This will maintain a more stable soil content there and help in preventing any more than normal settlement from occurring. We mention this because water accumulation near the foundation and foundation supports is a frequent source or contributor to its movement/ or settlement and can also be a source of attraction for termites.

Photo 3: Rear exterior view east end. No access for water to drain and low spot at NE corner.

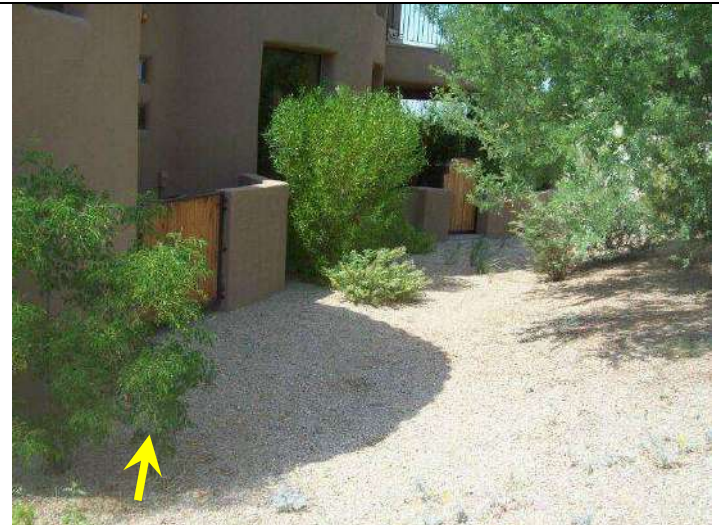
Photo 4: Low spot at NE corner of home. Water flow intended to flow west to natural wash.

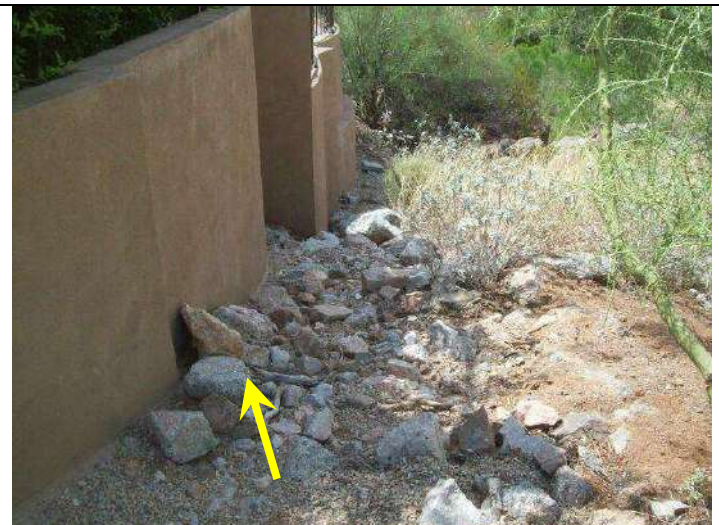
Photo 6: View of drainage along west edge of home. Minor erosion along base of masonry wall.

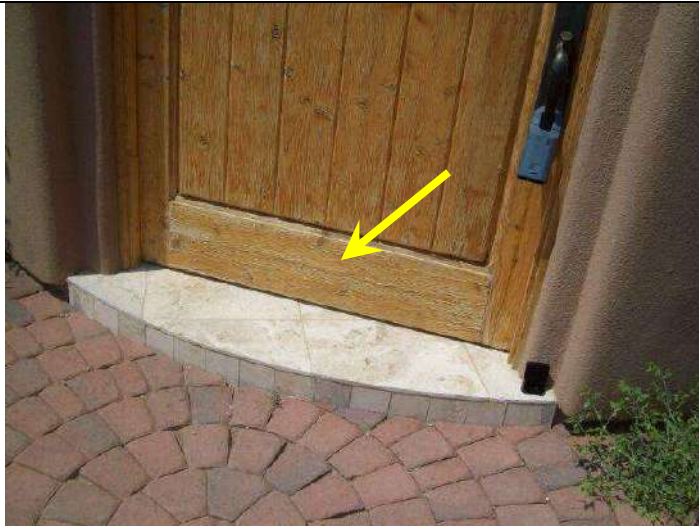
- The paint or stain on the front entry exterior door is showing signs of wear and deterioration (see photo 7). This is common for a house of this age and typically due to normal wear and tear on the home. We recommend you consider painting the wood door as part of general maintenance within the next year or two to provide proper protection and help prolong the life of the wood.

Photo 7: Stain wear on front entry door surface.

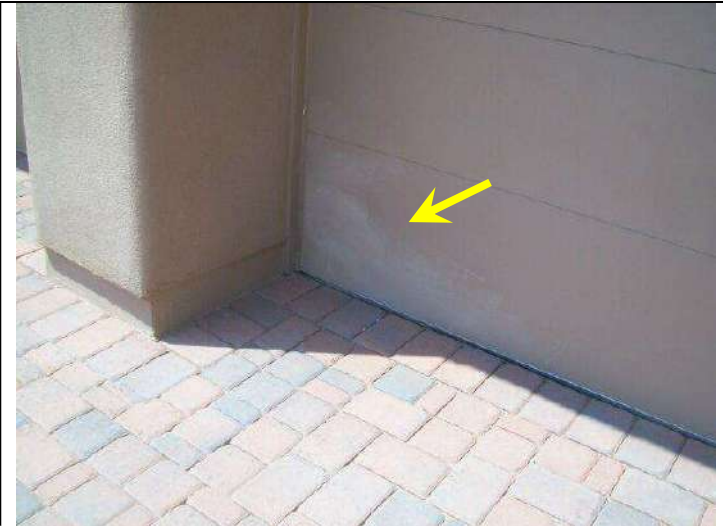
Photo 8: Paint mismatch on exterior surface of garage door.

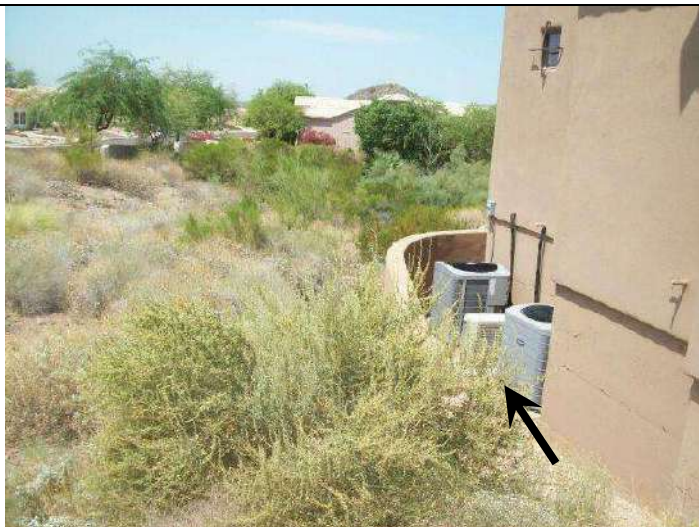
1. There were no drain holes along the bottom edge of the west wall at its north end and rear exterior HVAC wall at its west end (see photos 11 & 16). This does not allow any water runoff from the roof to drain from these areas. We recommend drain holes be installed and the areas graded to insure water drains away from the main home foundation areas. This will maintain a more stable soil content there and help in preventing any more than normal settlement from occurring. We mention this because water accumulation near the foundation and foundation supports is a frequent source or contributor to its movement/ or settlement and can also be a source of attraction for termites.

Photo 11: No access for water to drain from rear HVAC installation area.

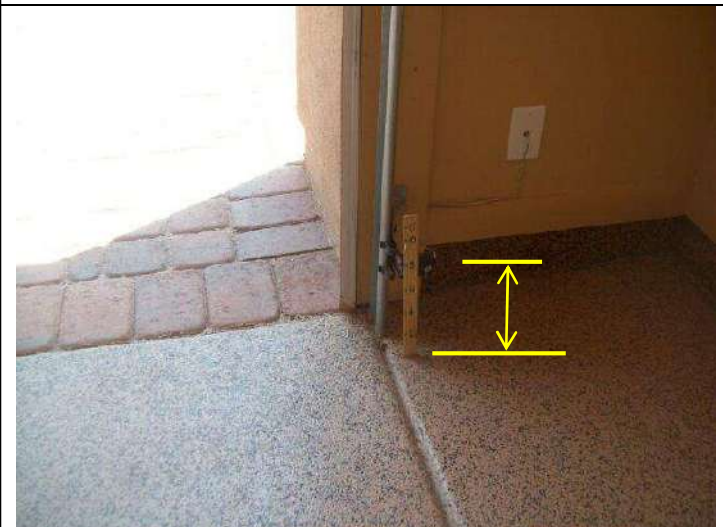
Photo 12: Electronic eyes installed at too high a level at two southernmost garage doors.

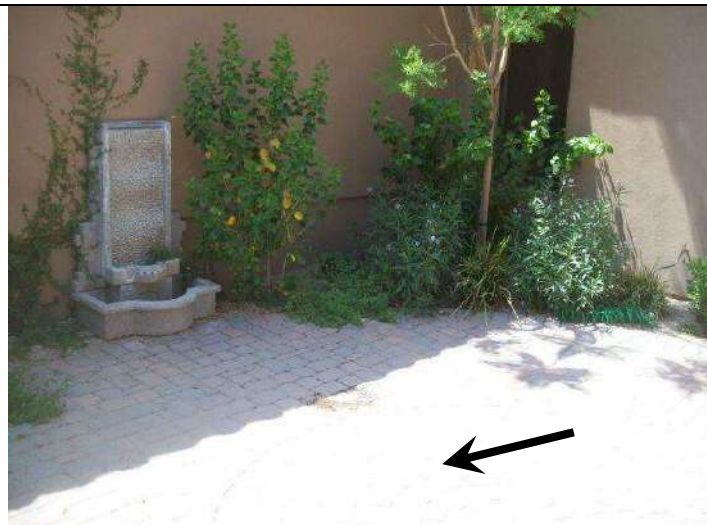
3. There was a drain line provided for water to drain from the front courtyard area (see photo 14). The drain line was not tested as part of this inspection. We recommend the drain be tested and periodically maintained as required to ensure adequate drainage is obtained and maintained.

Photo 14: Drain line in front courtyard area.

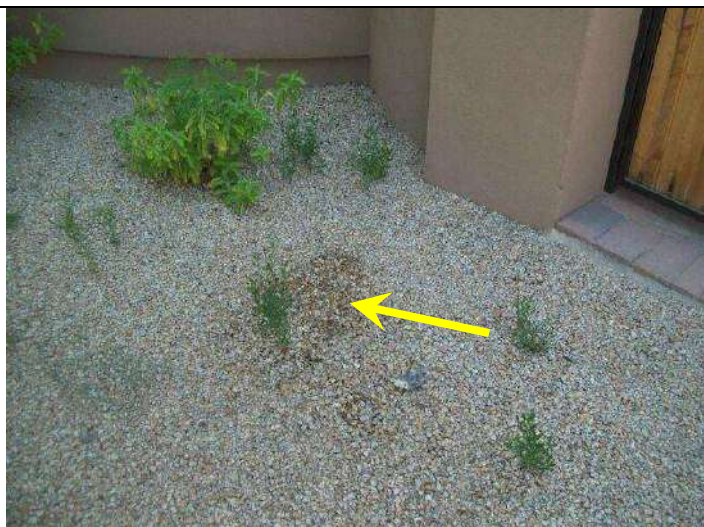
Photo 15: Signs of potential underground sprinkler system leak along front exterior at its west end.

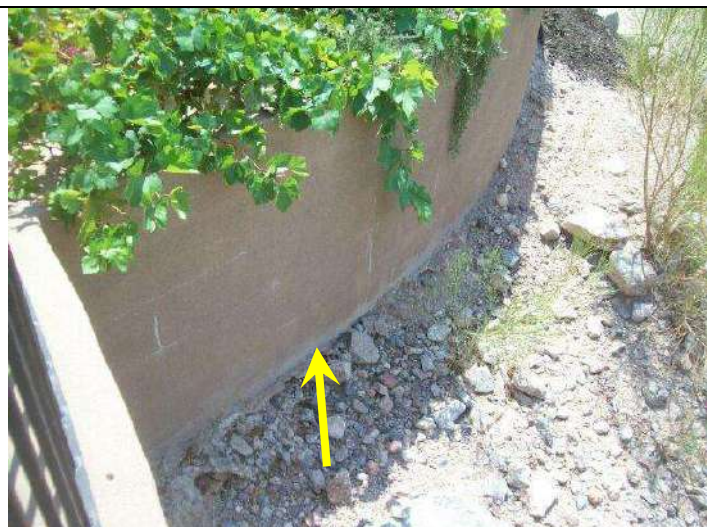
Photo 16: No weep holes noted at base of west masonry wall at its north end.

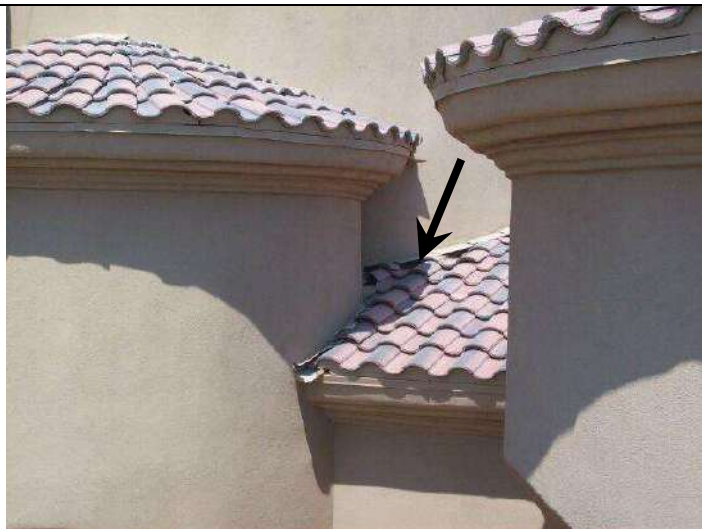
Photo 19: Slipped roof tiles above and east of front entry.

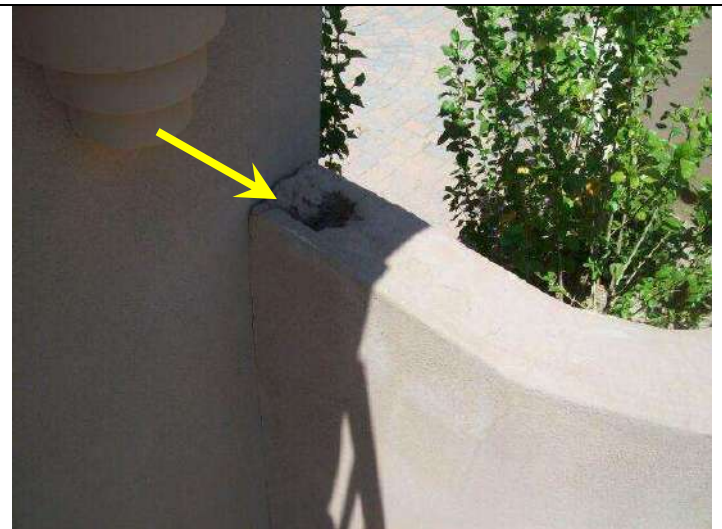
2. There were a couple of cells along the top edge of the east masonry wall that were not covered (see photo 20). This is not affecting the function of the wall, however it can allow water to penetrate to the areas below it. We recommend these areas be sealed and painted to provide protection and match the existing surface as part of general maintenance over the next year or two.

Photo 20: Top of front entry masonry wall not filled.

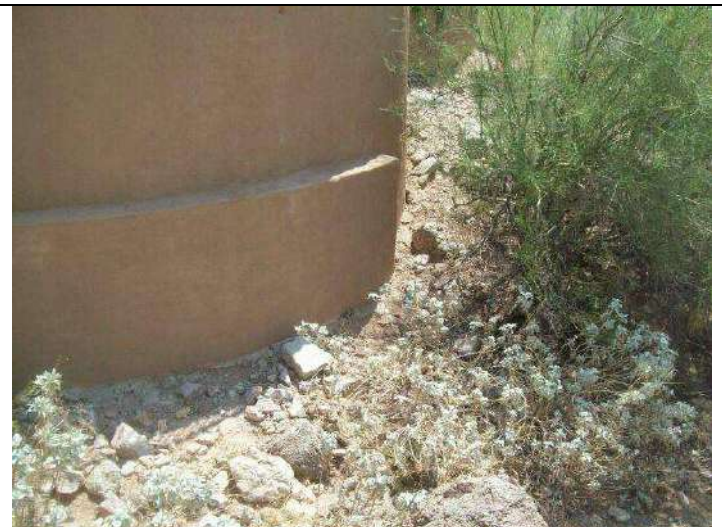
Photo 22: View of drainage along west edge of home. Minor erosion along base of masonry wall.

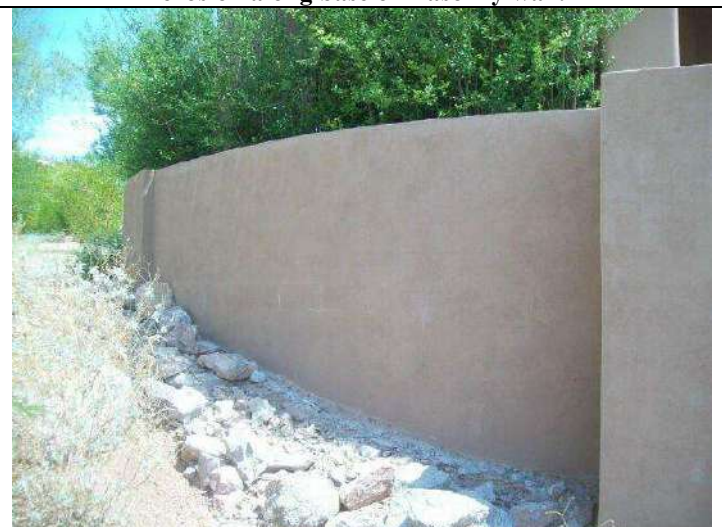
24). This is not affecting the function of the wall, however over time it can erode or under its foundation. We recommend erosion control methods be provided as part of general maintenance over the next year or two to ensure stability of the wall is maintained.

Photo 24: View of drainage along west edge of home. Minor erosion along base of masonry wall.

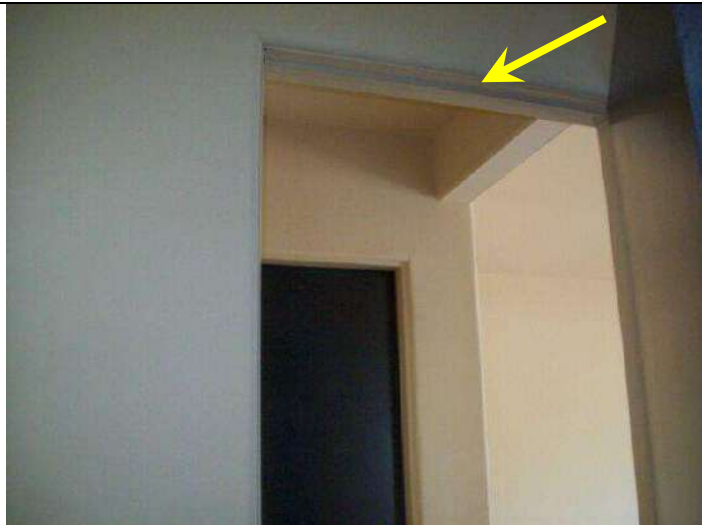
- There was no weather stripping around the perimeter of the exterior door from the rear work room to the garage (see photo 27). This can allow conditioned air to escape, as well as, allowing dirt and debris to enter inside the interior of the home. Weather stripping should be installed around the perimeter of this door as required to provide proper protection and help improve the overall energy efficiency of the home.

Photo 27: No weather stripping on entry door to conditioned work room off garage area.

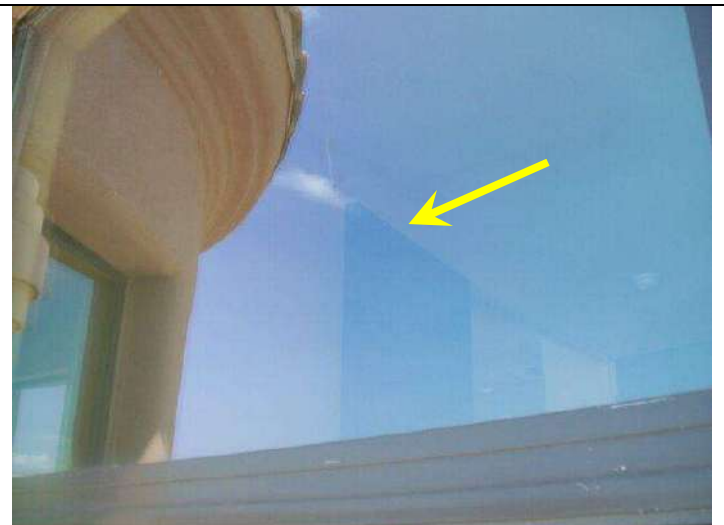
Photo 30: Scratching on surface of west exterior window upper level.

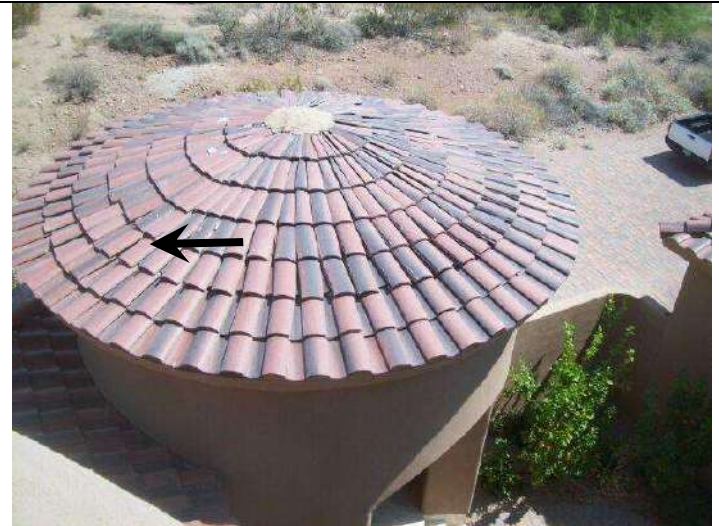
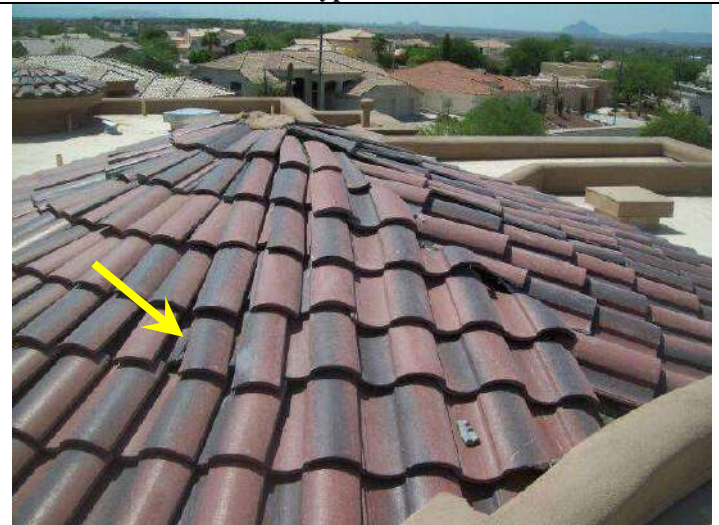
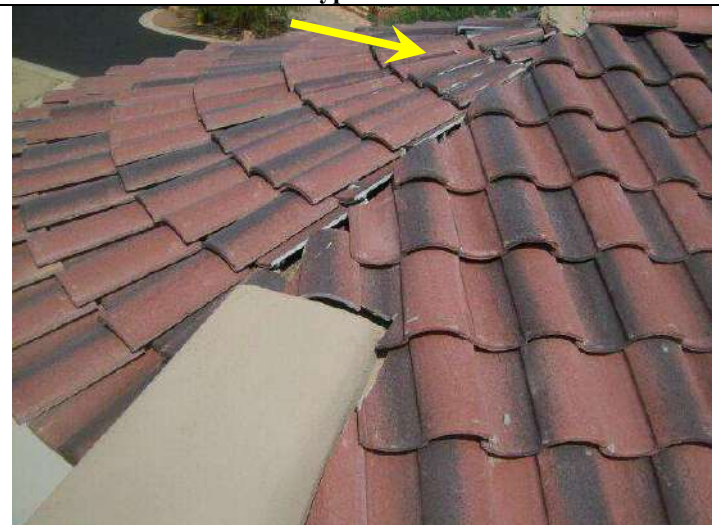
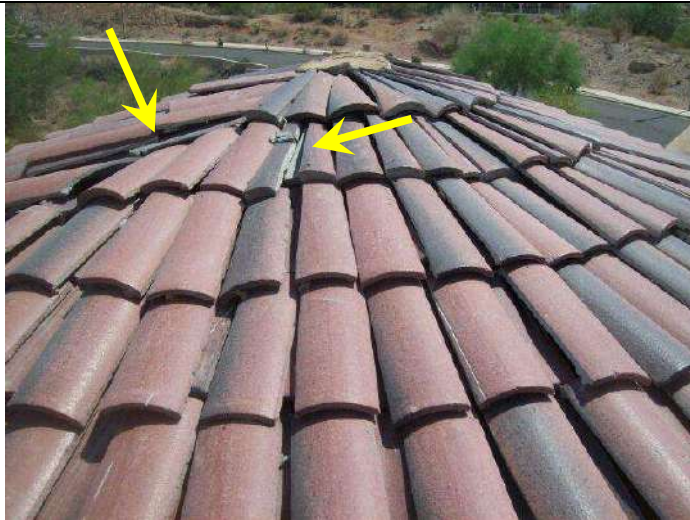
Photo 32: Slipped and unsecured tiles on round tower tile surface and typical of these areas.

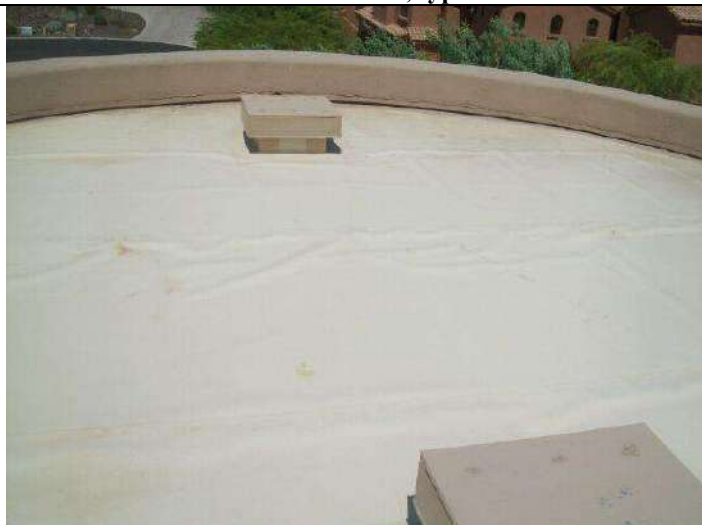
Photo 35: Buckling of rubber membrane surface at NW corner of home.

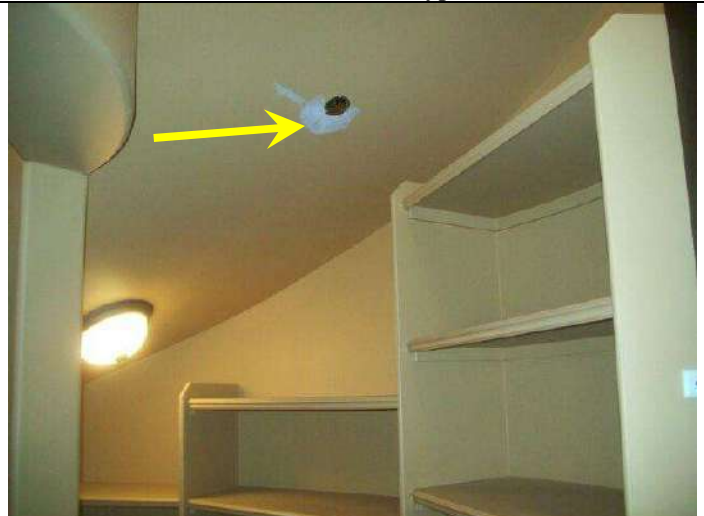
Photo 40: Patch not painted in kitchen pantry area.

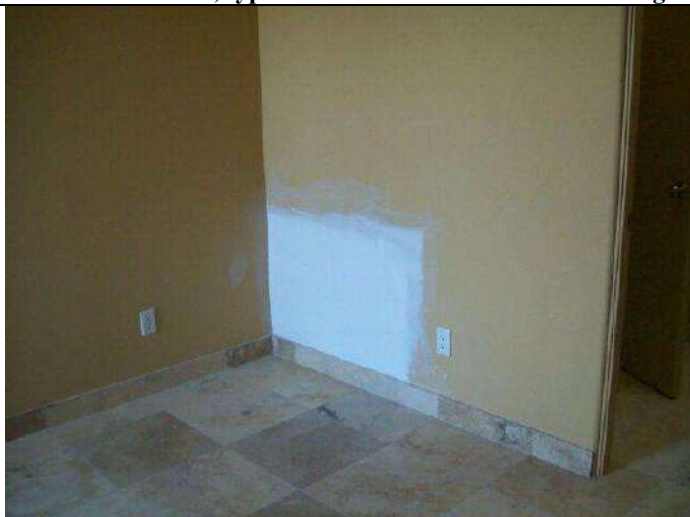
Photo 41: Patch not painted in lower level bedroom.

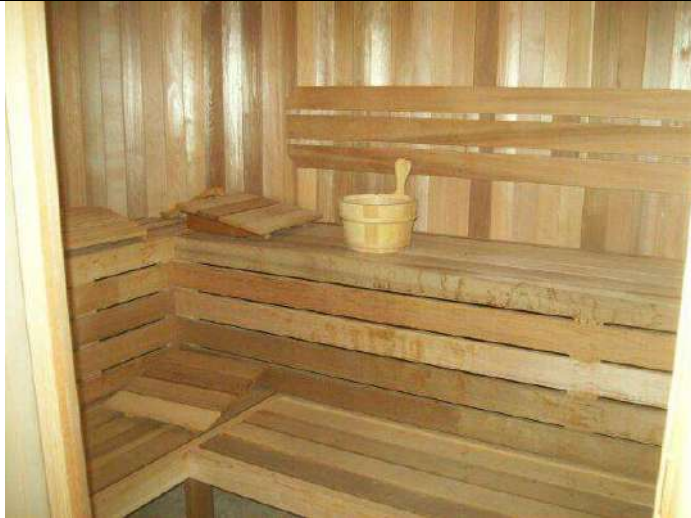
Photo 43: Sauna in lower level bedroom not tested.

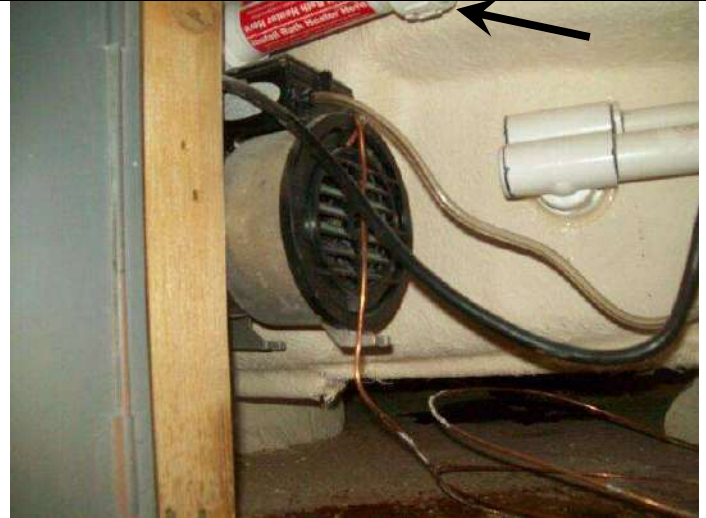
Photo 44: Water leak in plumbing joint for MBR bathroom Jacuzzi tub pump.
