RE: Manufactured Home FHA Permanent Foundation Engineering Certification
 1234 E. Some Place, Parcel #123-456-789H
 Anywhere, AZ

Property Inspection Report

FHA/ HUD Permanent Foundation Engineering Certification

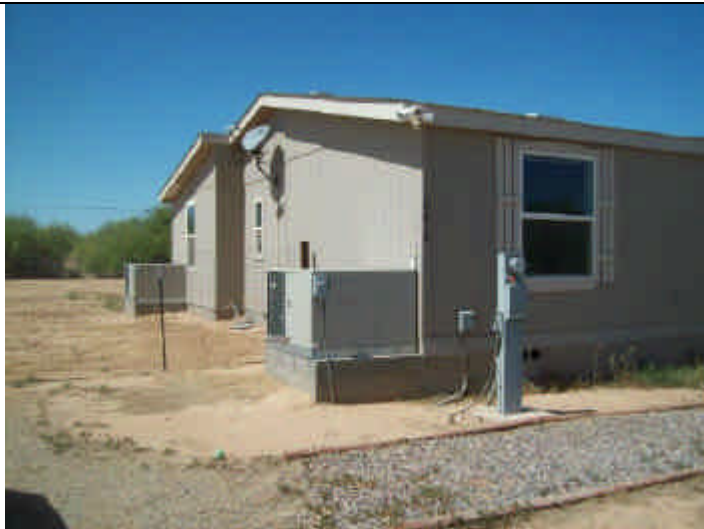
Photo 1: Front exterior and side view.

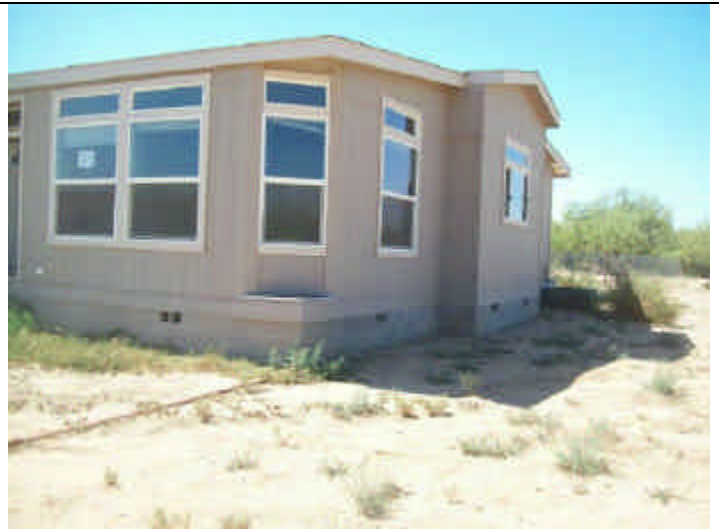
Photo 2: Front exterior and side view.

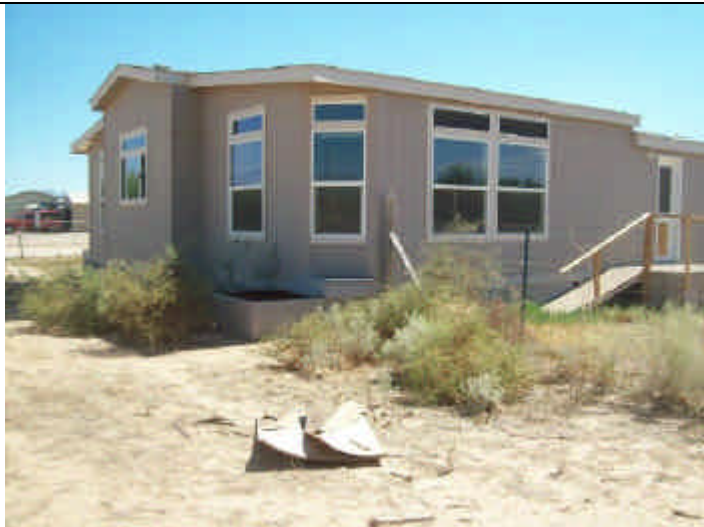
Photo 3: Rear exterior and side view.

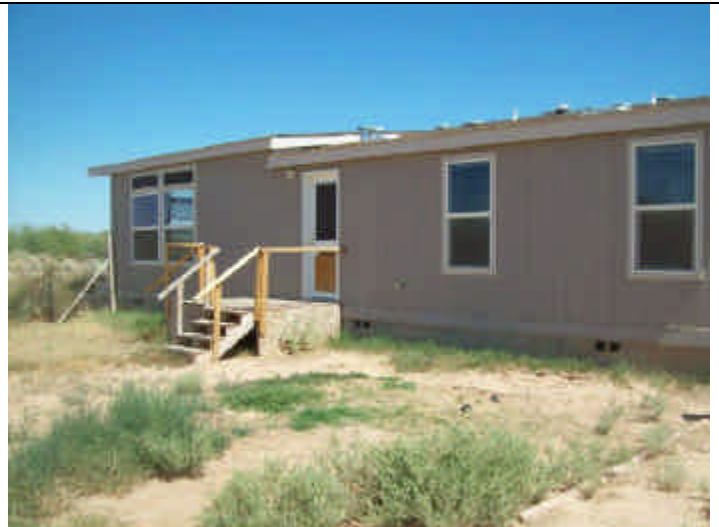
Photo 4: Rear exterior view.

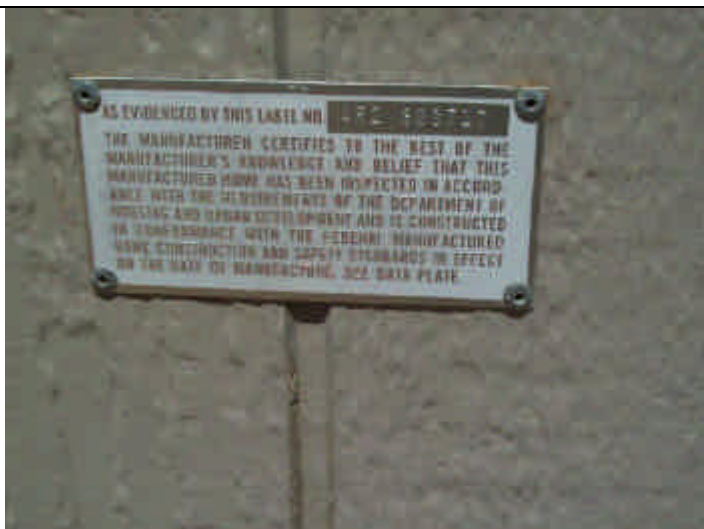
Photo 5: Arizona HUD tag one of two.

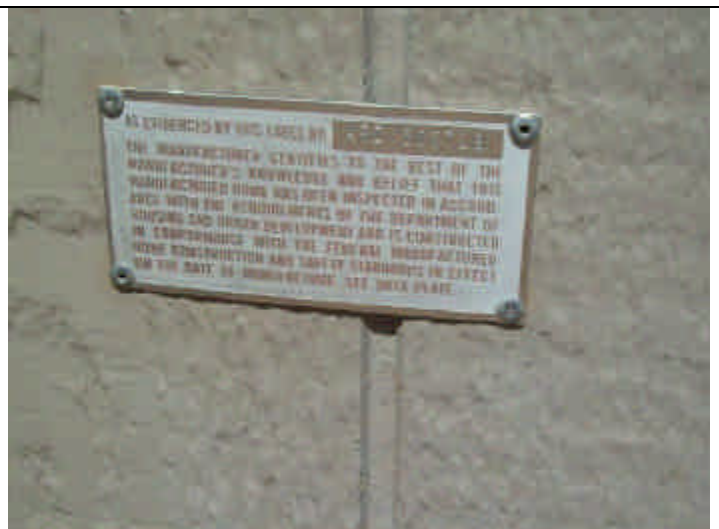
Photo 6: Arizona HUD tag two of two.

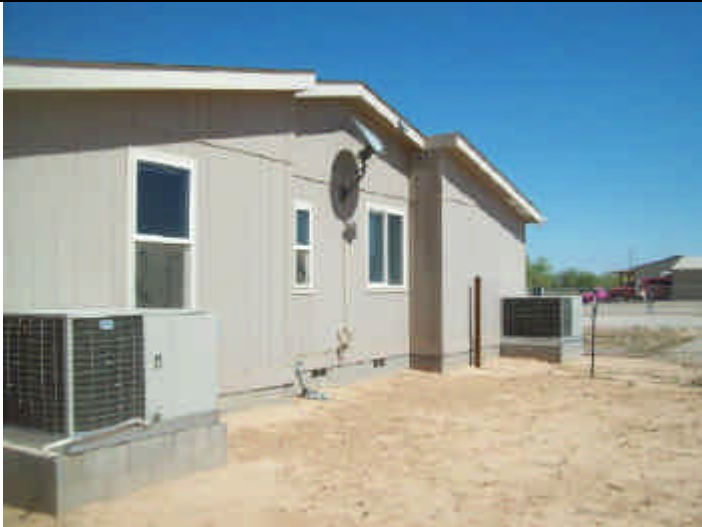
Photo 7: Rear exterior and side view.

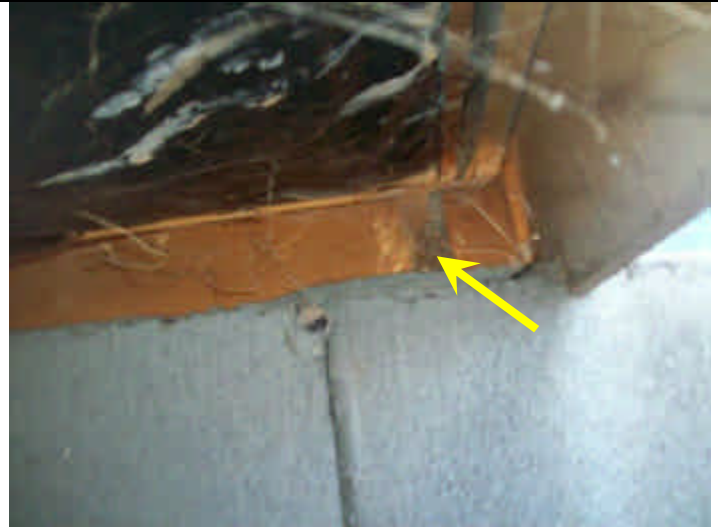
Photo 8: Crawl space view showing metal straps from stem wall and tied to exterior wall.

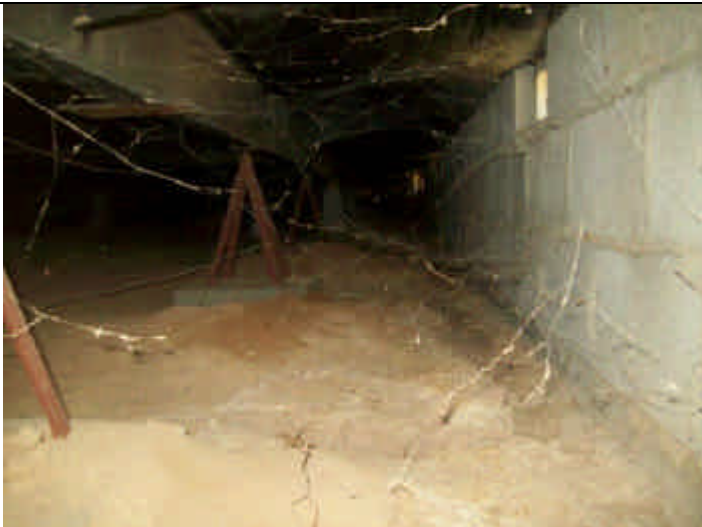
Per the on-site inspection completed and as outlined in the attached photos and attachments, the chassis is supported by equally spaced masonry and metal piers mounted on four inch thick, sixteen by sixteen inch wide masonry blocks that are laying on the soil (see photos). The structure or walls of the home are tied to a masonry and reinforced CMU stem wall via conventional metal straps anchored to the masonry CMU wall around its perimeter (see photos). The floor of the home is near or slightly above ground level, therefore the crawl space is mostly dug out. The side dirt wall around the perimeter is supported by a reinforced masonry CMU wall construction installed over reinforced concrete footings (see photos). As with similarly constructed homes, this method of installation, over a relatively long period of time may have a tendency to settle. Therefore, periodic adjustments may be required.

Photo 9: Crawl space view showing masonry & metal piers on concrete pads and perimeter retaining wall.

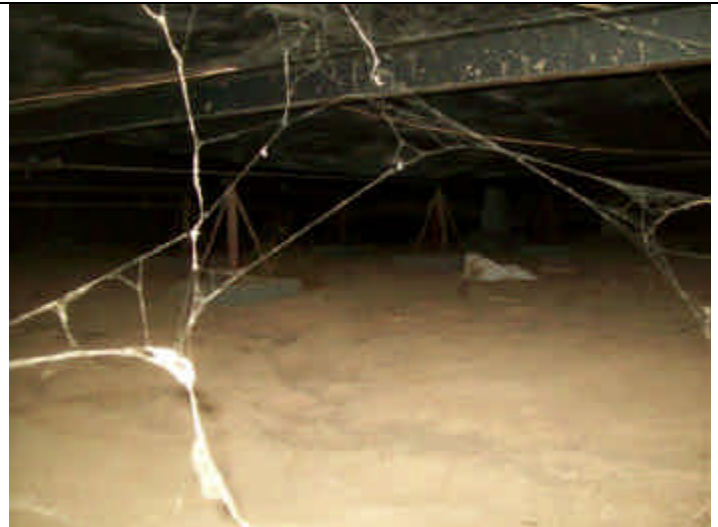
Photo 10: Crawl space view showing masonry & metal piers on concrete pads and perimeter retaining wall.

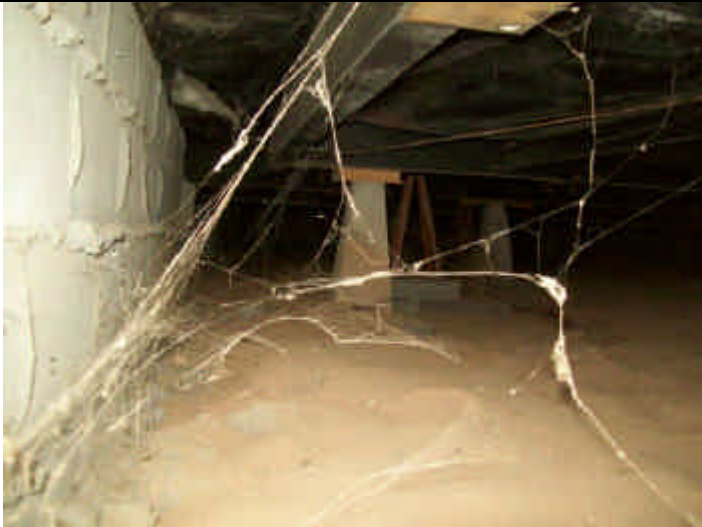
Photo 11: Crawl space view showing masonry & metal piers on concrete pads and perimeter retaining wall.
